# SHORE POINT ARCHITECTURE, PA

## SUPPLEMENT TO HPC APPLICATION

Date: November 5, 2022  
SPA Job Number: 2022-30 (Lambdin Residence)  
Property Address: 100 Abbott Avenue, Ocean Grove

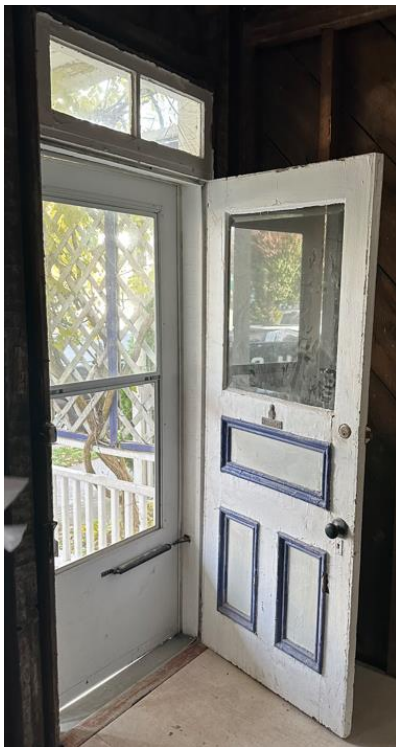
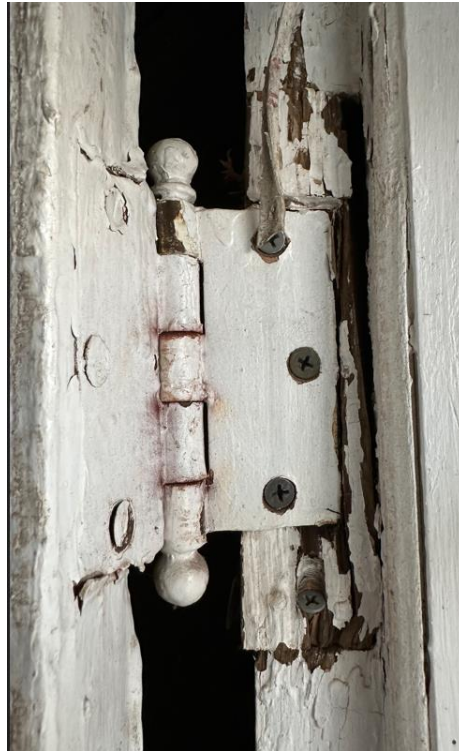
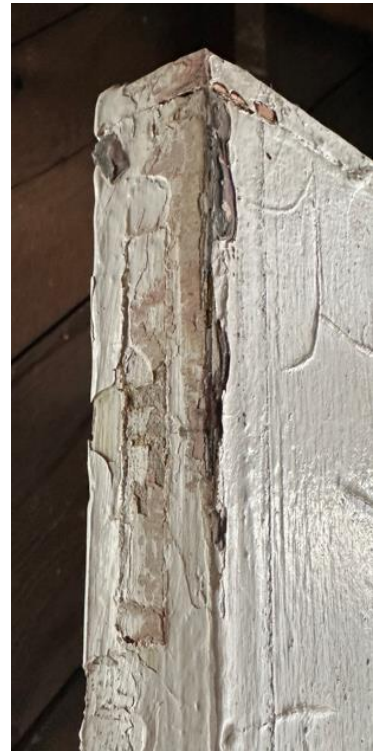
**Tag:** 1-A

**Condition:** This door is in very poor condition. It has been filled, repaired, planed (at the edges), drilled (for new hardware) and is beyond its useful life. Planing was so severe that tenon joints are visible at edges. Rot is so significant paint will no longer adhere to the door.

**Replacement:** Custom wood door raised panel with clear glass and transom to match existing size and style (including panel configuration). Paint BM Hale Navy.

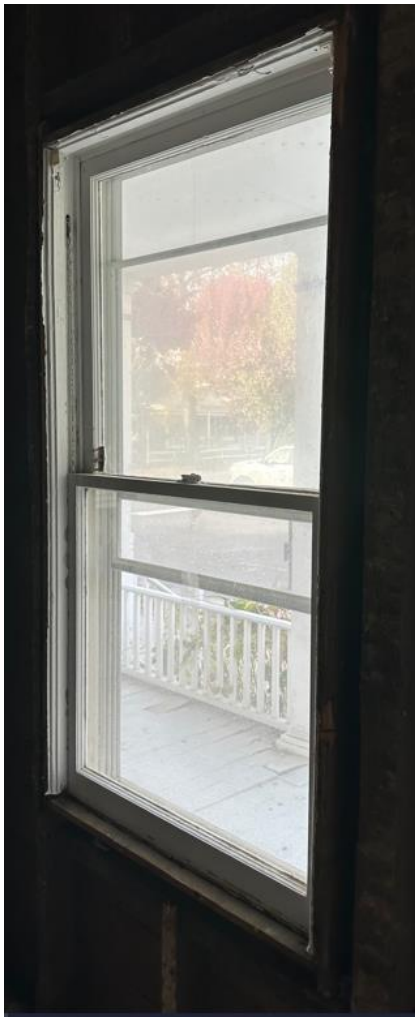
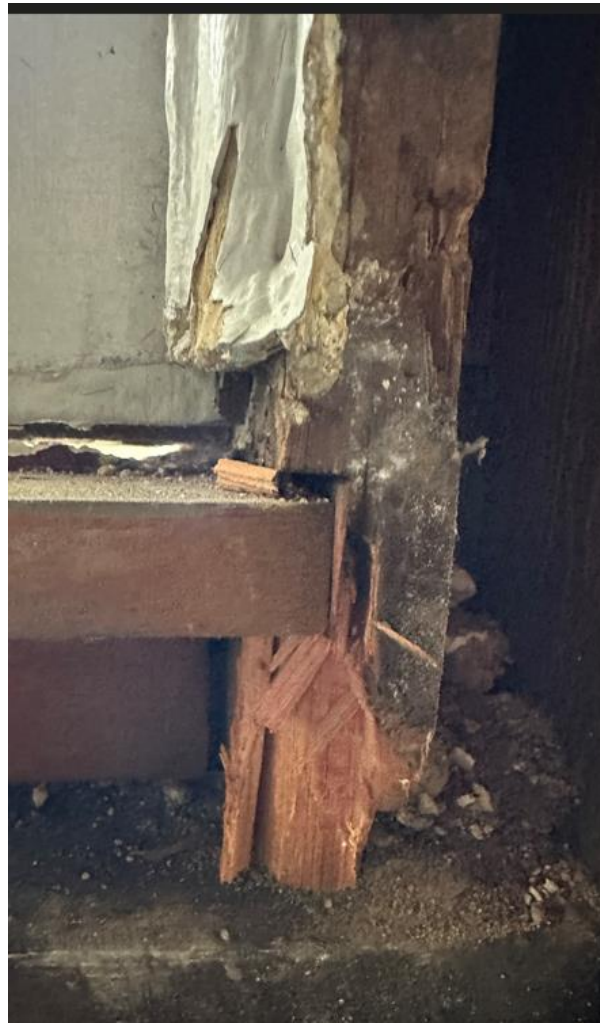
**Tag:** 1-B

**Condition:** Frame is in poor condition. Sashes are in fair condition.

**Replacement:** Andersen 400 series 2:2 (SDL) DH window, size to match existing, color: white

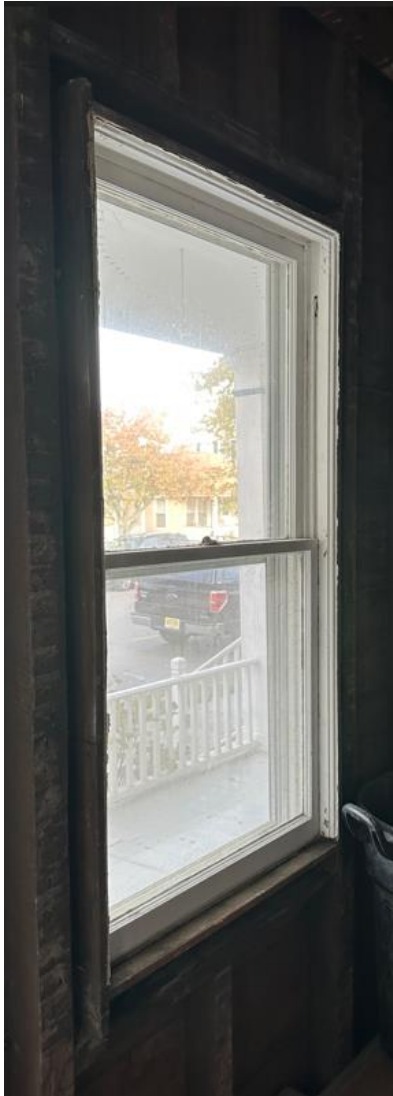
**Tag:** 1-C

**Condition:** Frame is in fair condition. Sashes are in fair condition.

**Replacement:** Andersen 400 series 2:2 (SDL) DH window, size to match existing, color: white

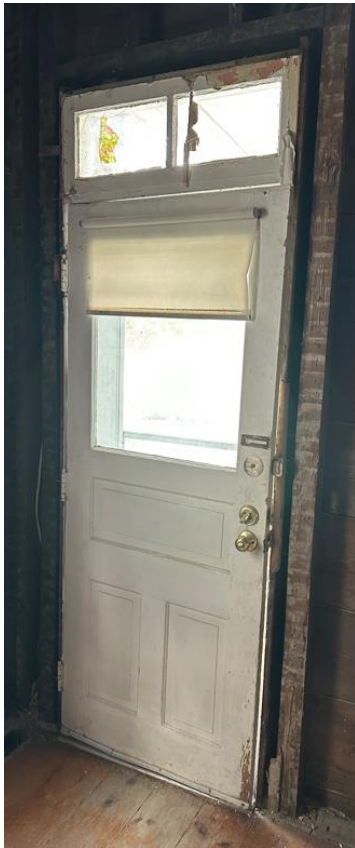
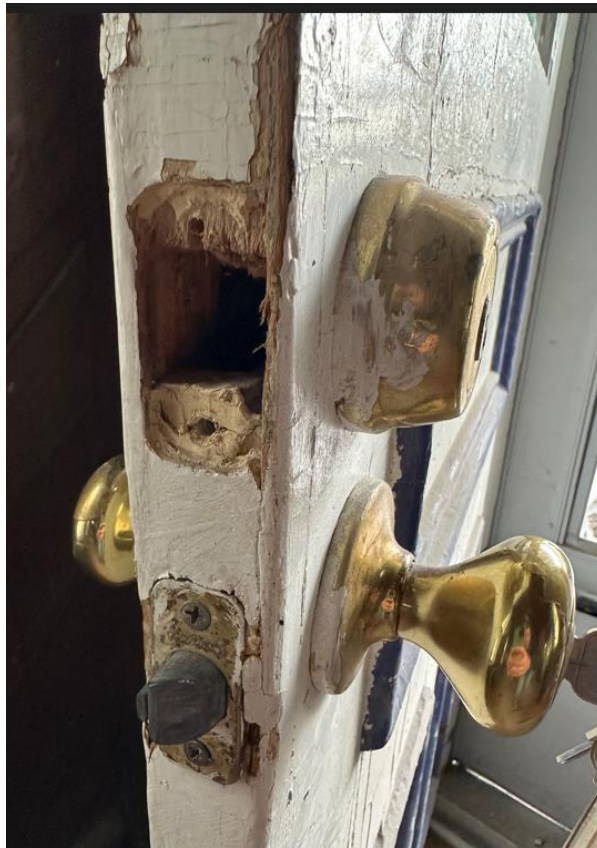
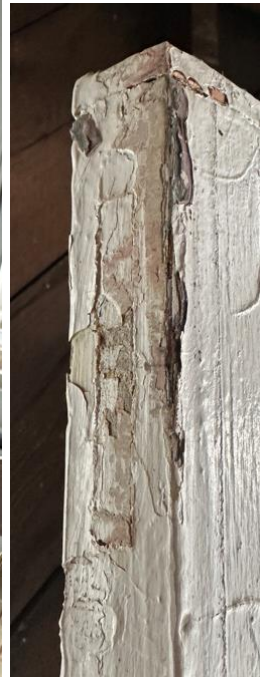
**Tag:** 1-D

**Condition:** This door is in very poor condition. It has been filled, repaired, planed (at the edges), drilled (for new hardware) and is beyond its useful life. Planing was so severe that tenon joints are visible at edges. Rot is so significant paint will no longer adhere to the door.

**Replacement:** Custom wood door raised panel with clear glass and transom to match existing size and style (including panel configuration). Paint BM Hale Navy.

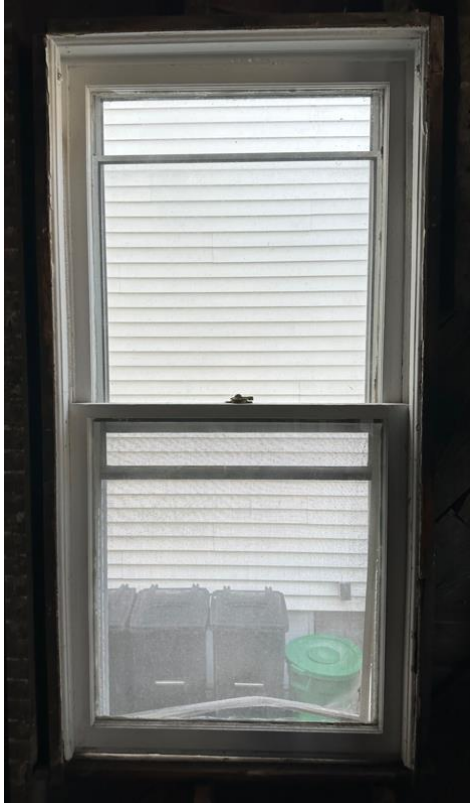
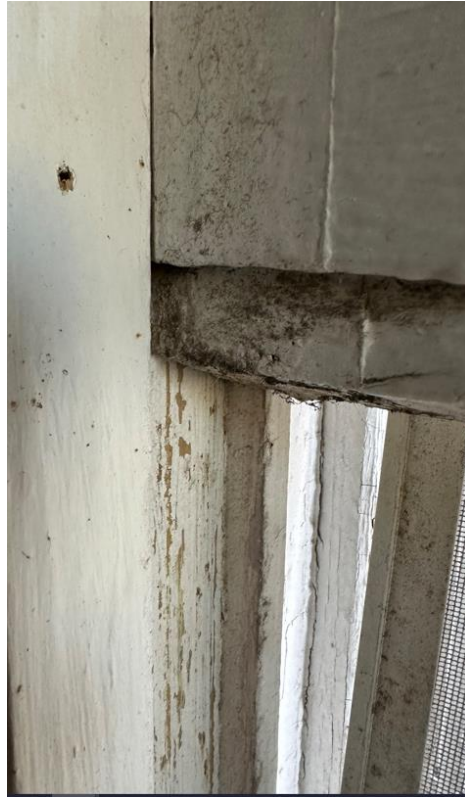
**Tag:** 1-E

**Condition:** Frame is in fair condition. Sashes are in poor condition (severely notched at lower sash)

**Replacement:** Andersen 400 series 2:2 (SDL) DH window, size to match existing, color: white

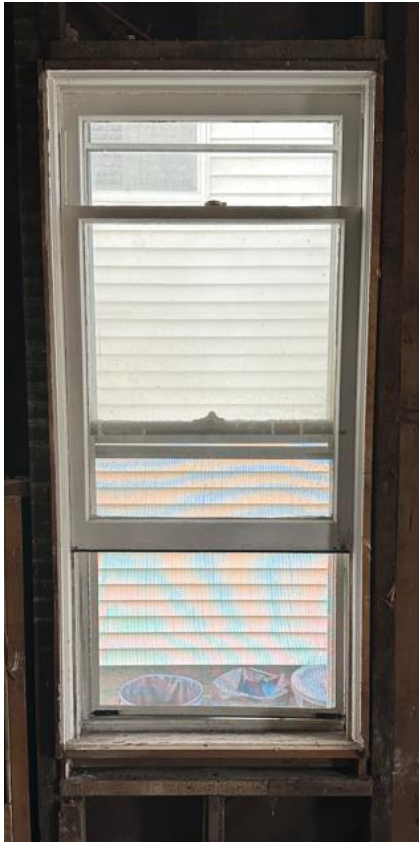
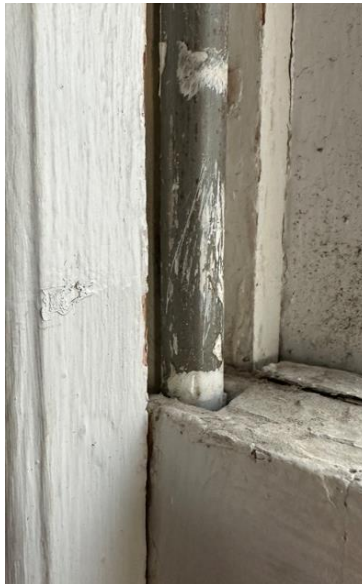
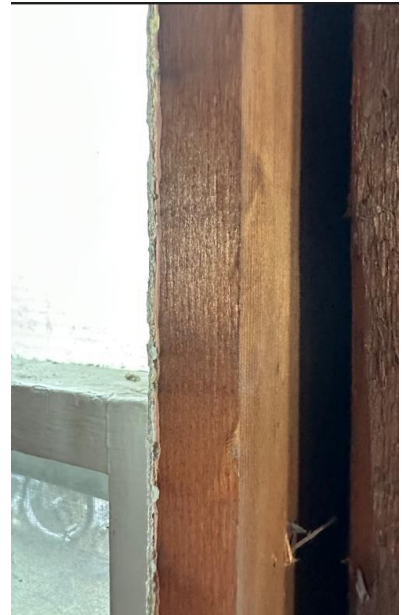
**Tag:** 1-F

**Condition:** Frame is in fair condition. Sashes are in fair condition.

**Replacement:** Andersen 400 series 2:2 (SDL) DH window, size to match existing, color: white

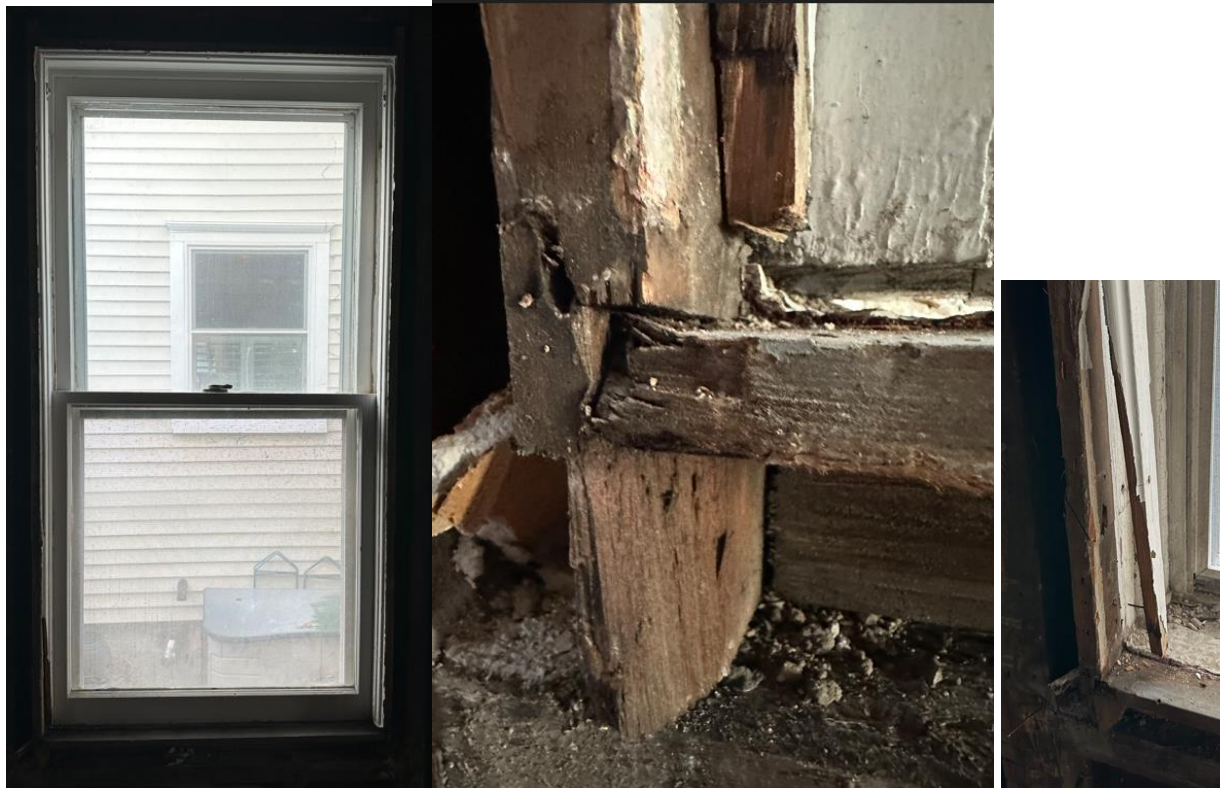
**Tag:** 1-H

**Condition:** Frame is in poor condition. Upper sash in fair condition. Lower sash in poor condition.

**Replacement:** Andersen 400 series 2:2 (SDL) DH window, size to match existing, color: white

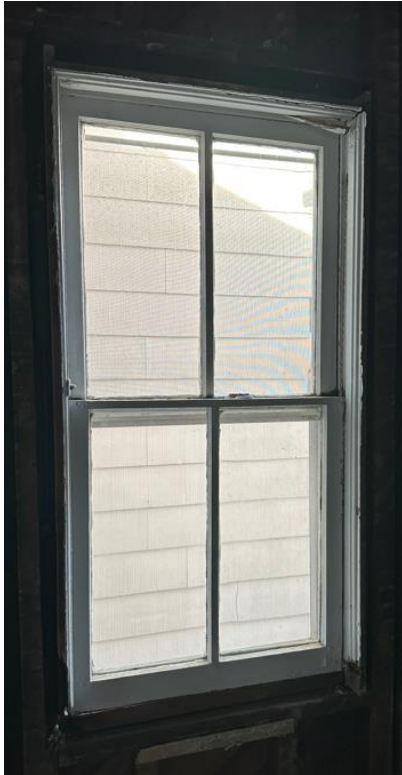
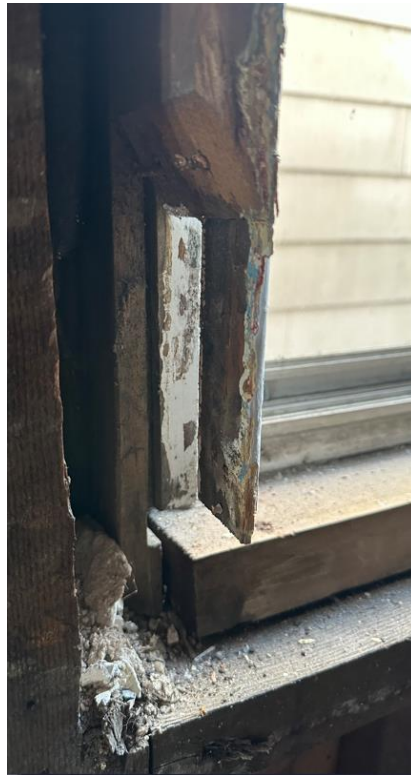
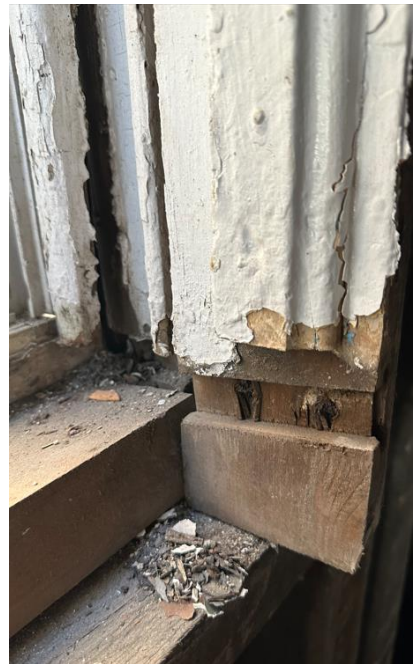
**Tag:** 1-P

**Condition:** Frame is in very poor condition. Requires full reconstruction. Sashes in very poor condition. Require extensive repairs. Poorly maintained, led to significant deterioration.

**Replacement:** Andersen 400 series 2:2 (SDL) DH window, size to match existing, color: white

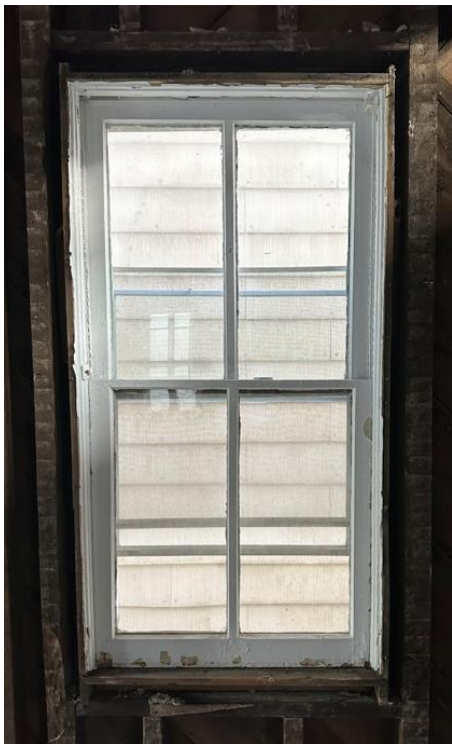
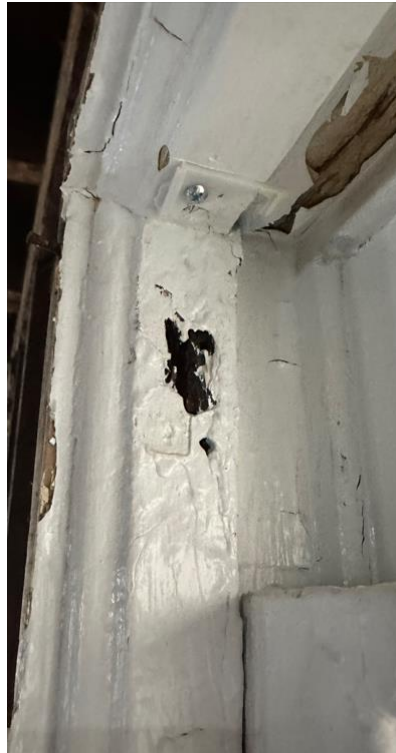
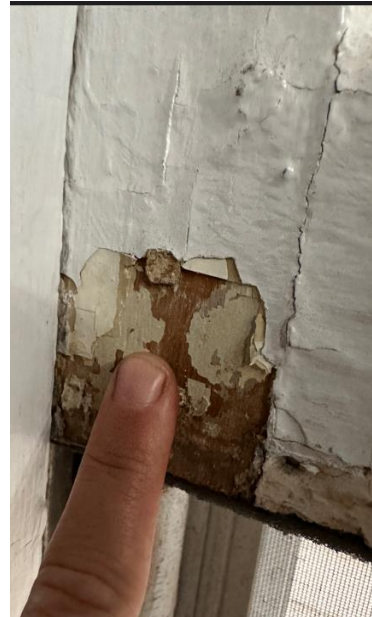
**Tag:** 1-Q

**Condition:** Frame is in very poor condition. Requires full reconstruction. Sashes in very poor condition. Require extensive repairs. Poorly maintained, led to significant deterioration.

**Replacement:** Andersen 400 series 2:2 (SDL) DH window, size to match existing, color: white

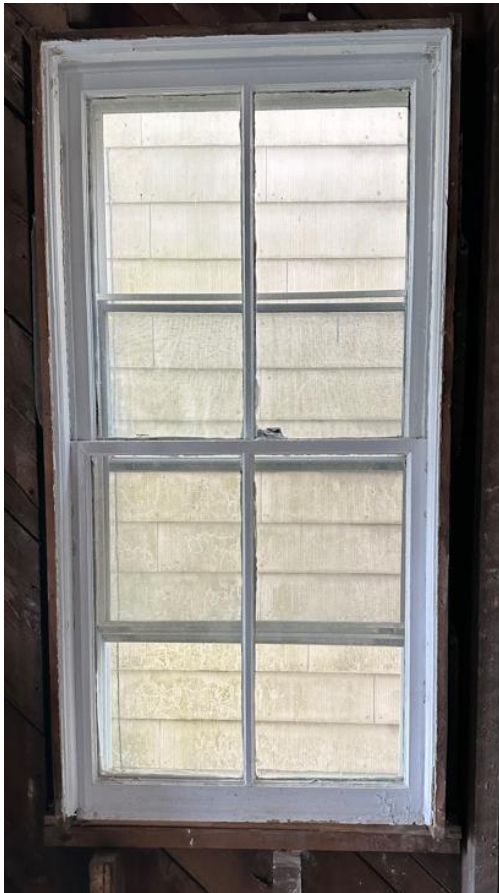
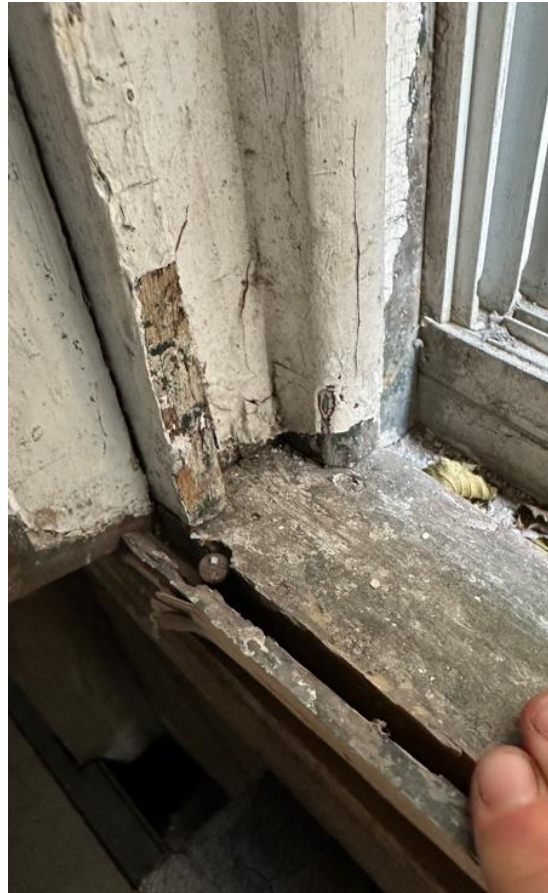
**Tag:** 1-R

**Condition:** Frame is in very poor condition. Requires full reconstruction. Sashes in very poor condition. Require extensive repairs. Poorly maintained, led to significant deterioration.

**Replacement:** Andersen 400 series 2:2 (SDL) DH window, size to match existing, color: white

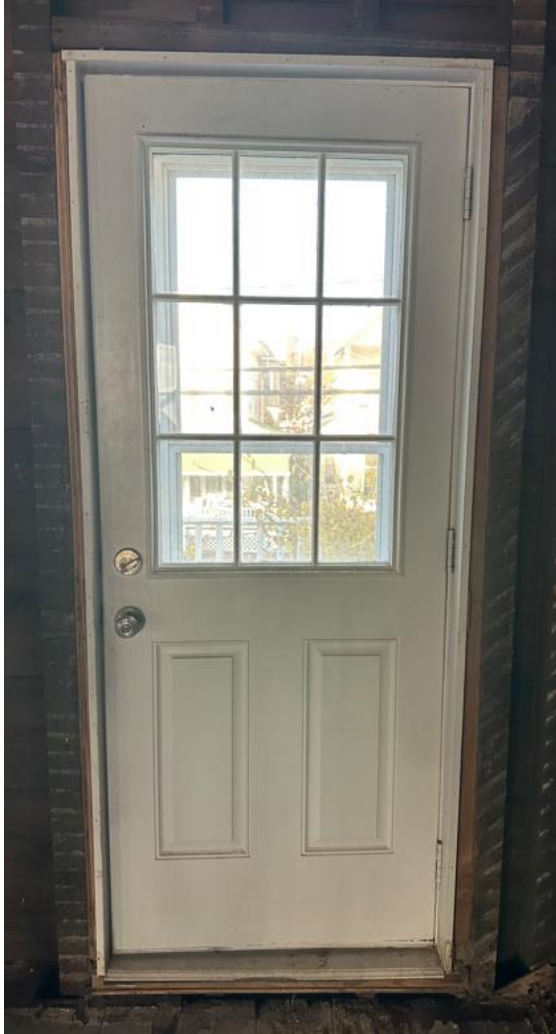
**Tag:** 2-A

**Condition:** N/A (new, modern door)

**Replacement:** Custom wood door raised panel with clear glass to match existing size and style (including panel configuration) of door 1-A (from first floor). Paint BM Hale Navy.

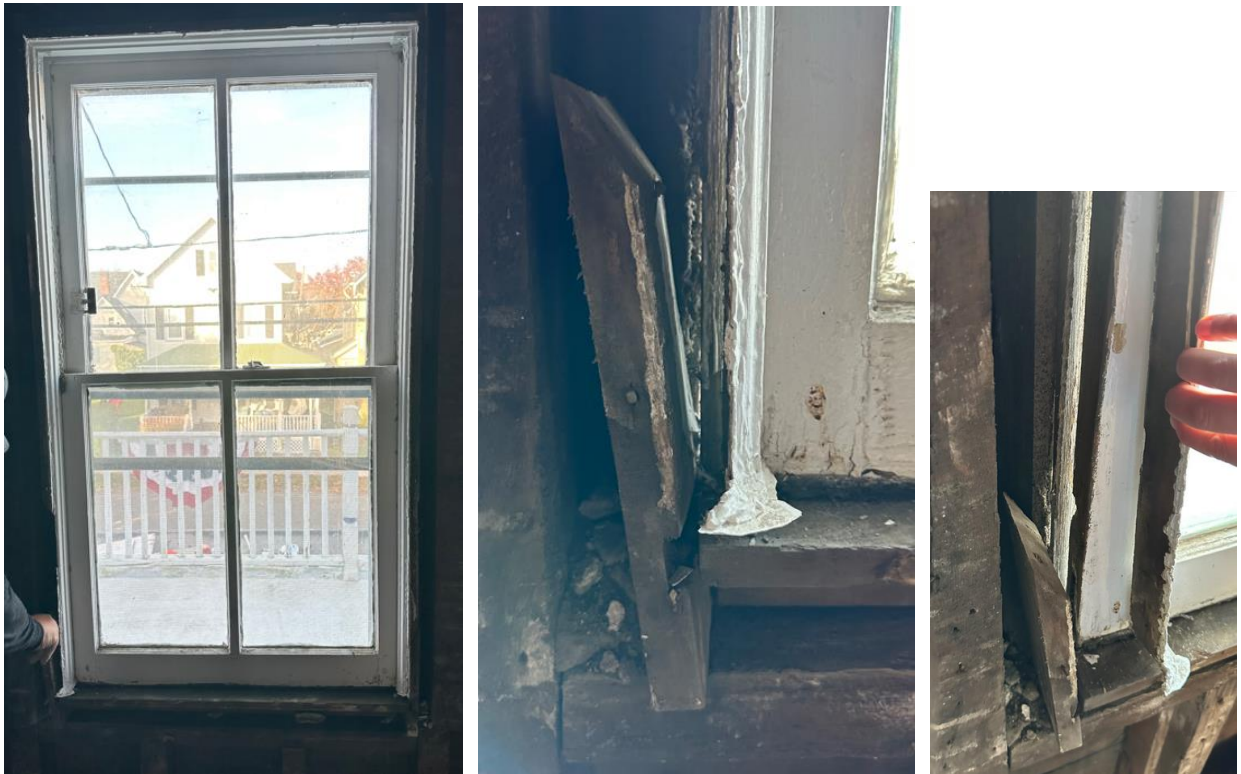
**Tag:** 2-B

**Condition:** Frame is in very poor condition. Requires full reconstruction. Sashes in very poor condition. Require extensive repairs. Poorly maintained, led to significant deterioration.

**Replacement:** Andersen 400 series 2:2 (SDL) DH window, size to match existing, color: white

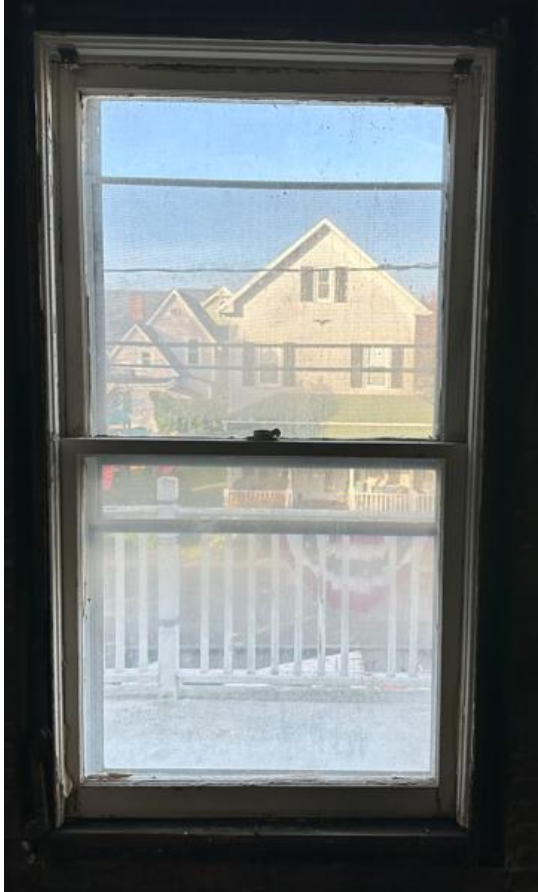
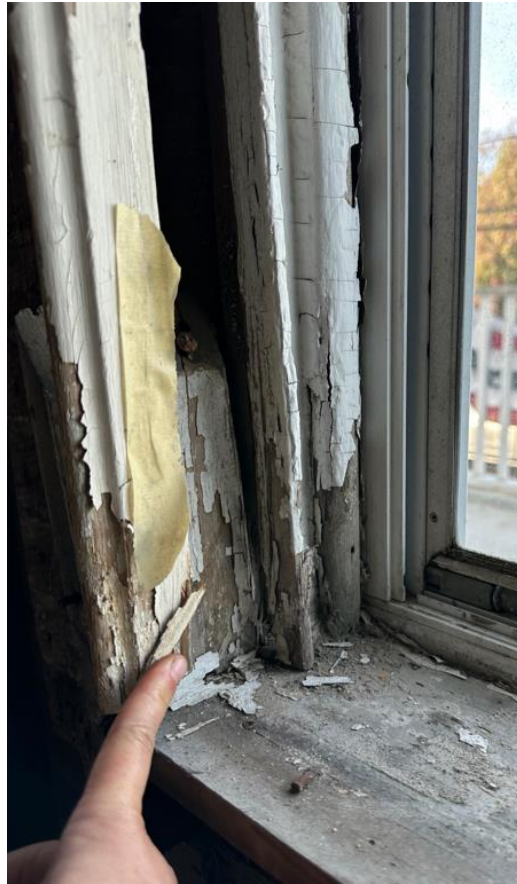
**Tag:** 2-C

**Condition:** Frame is in poor condition. Sashes in fair condition.

**Replacement:** Andersen 400 series 2:2 (SDL) DH window, size to match existing, color: white

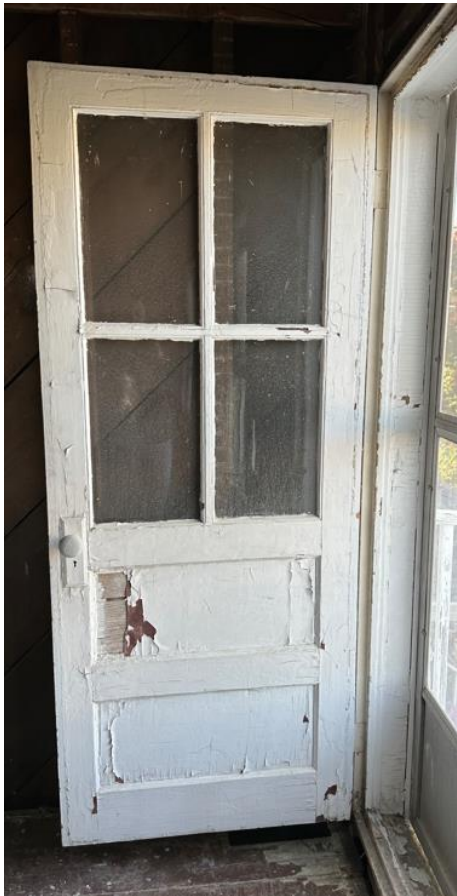
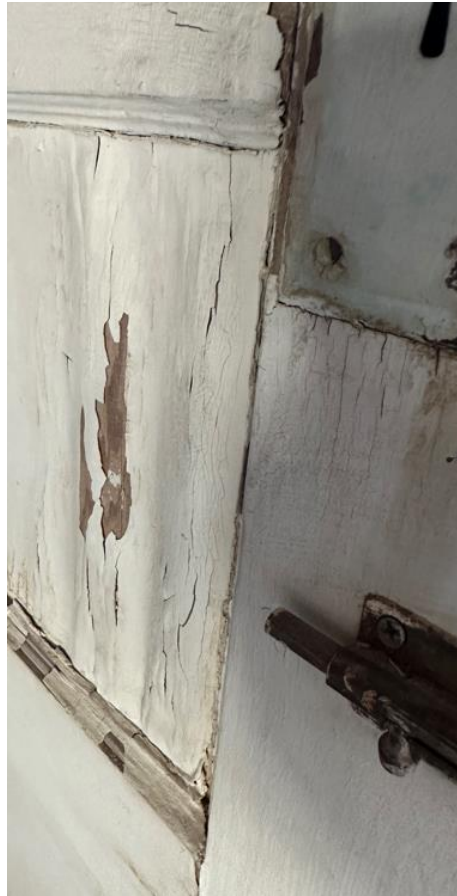
**Tag:** 2-D

**Condition:** Very poor, significant rot at door and on frame. Paint bubbling on interior surface of door.

**Replacement:** Custom wood door raised panel with clear glass to match existing size and style (including panel configuration) of door 1-A (from first floor). Paint BM Hale Navy.

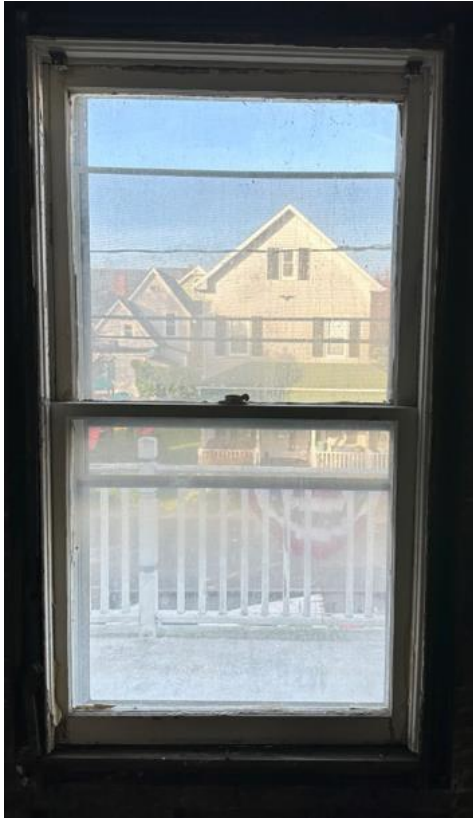
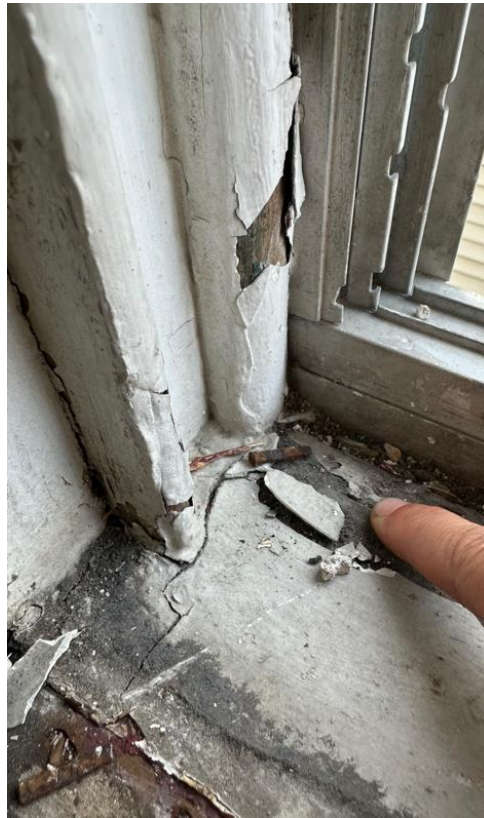
**Tag:** 2-E

**Condition:** Frame is in poor condition. Sashes in fair condition.

**Replacement:** Andersen 400 series 2:2 (SDL) DH window, size to match existing, color: white

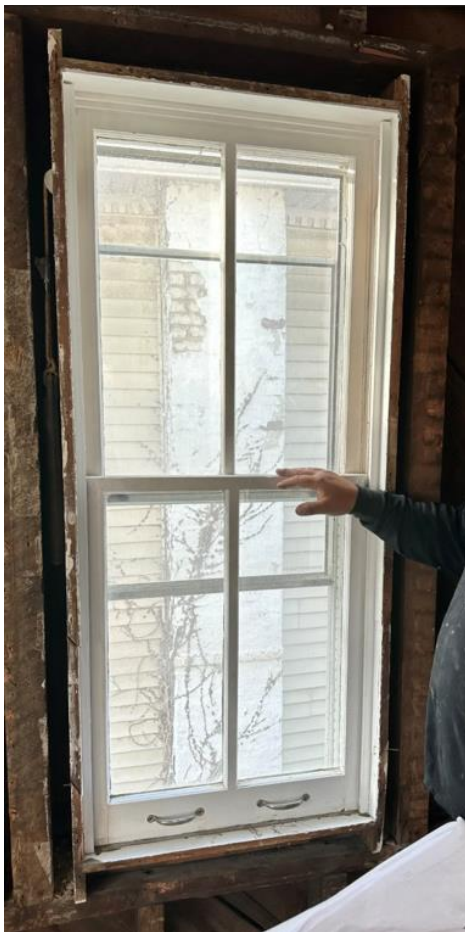
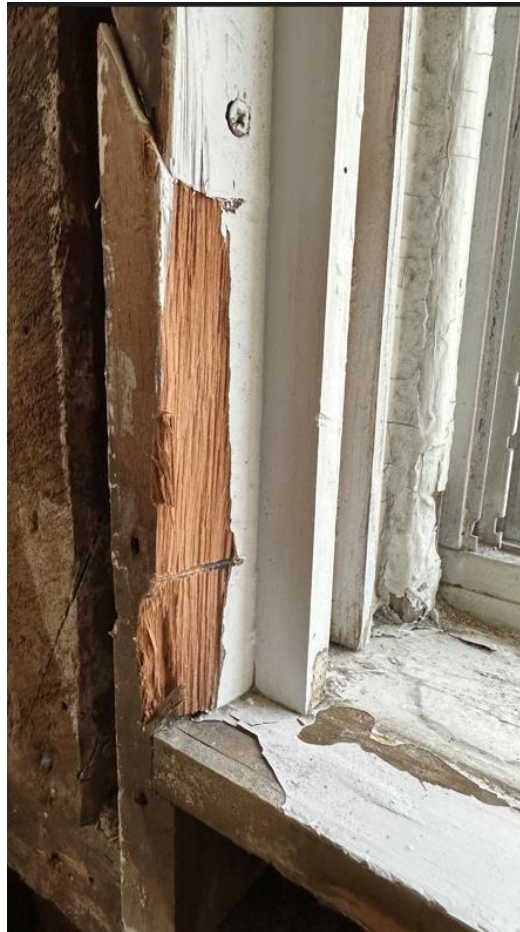
**Tag:** 2-F

**Condition:** Frame is in very poor condition. Requires full reconstruction. Sashes in very poor condition. Require extensive repairs. Poorly maintained and repaired inappropriately over the years. led to significant deterioration.

**Replacement:** Andersen 400 series 2:2 (SDL) DH window, size to match existing, color: white

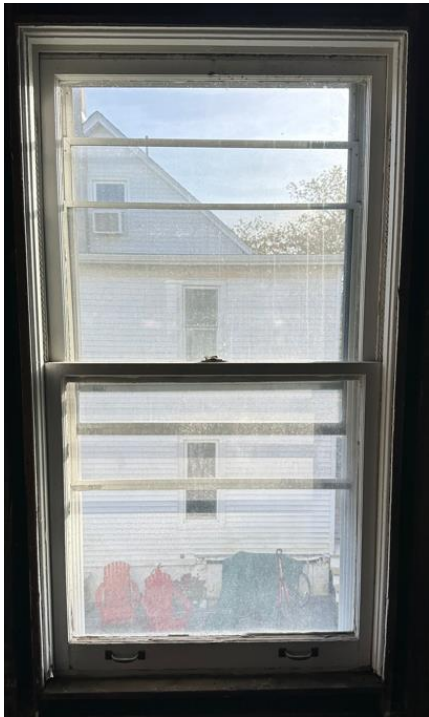
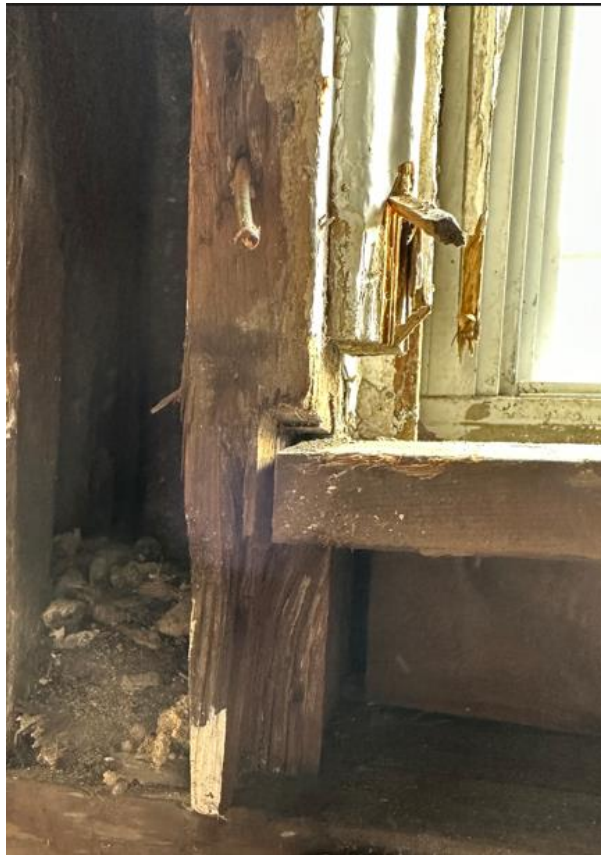
**Tag:** 2-G

**Condition:** Frame is in poor condition. Sashes in poor condition. Significant rot.

**Replacement:** Andersen 400 series 2:2 (SDL) DH window, size to match existing, color: white

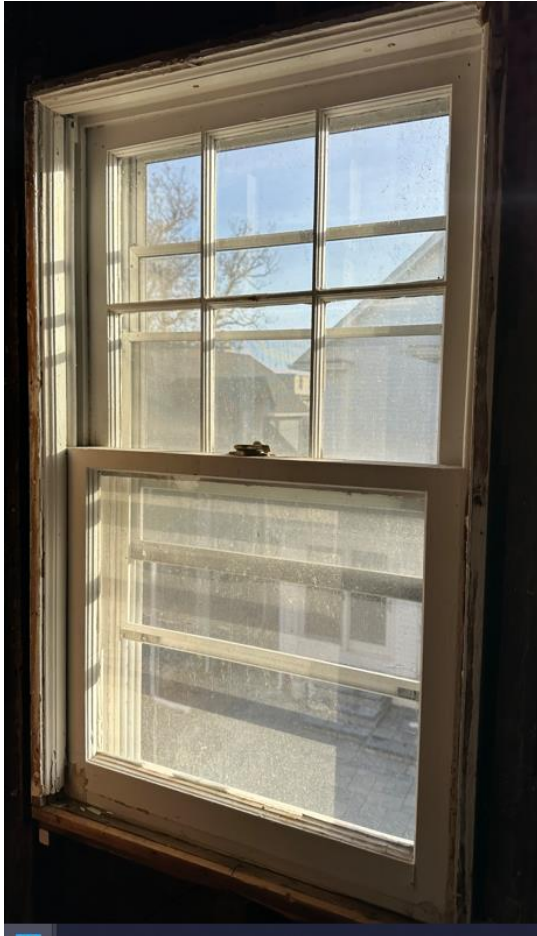
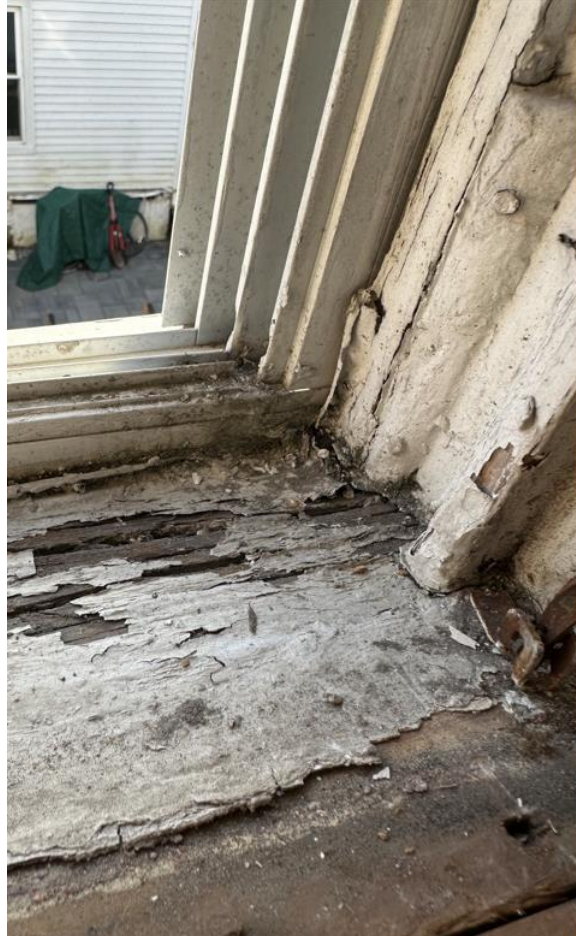
**Tag:** 2-H

**Condition:** Frame is in poor condition. Sashes in poor condition. Significant rot.

**Replacement:** Andersen 400 series 2:2 (SDL) DH window, size to match existing, color: white

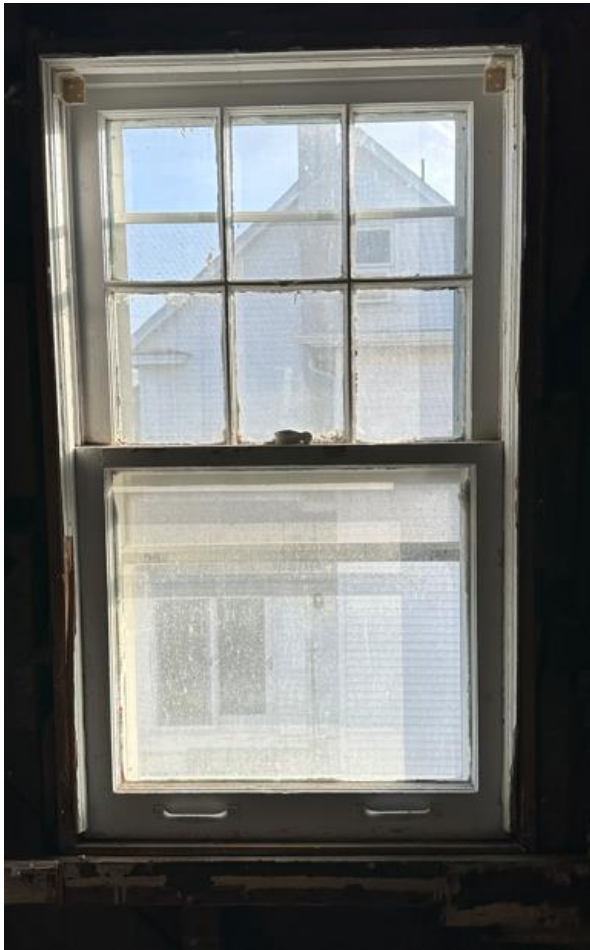
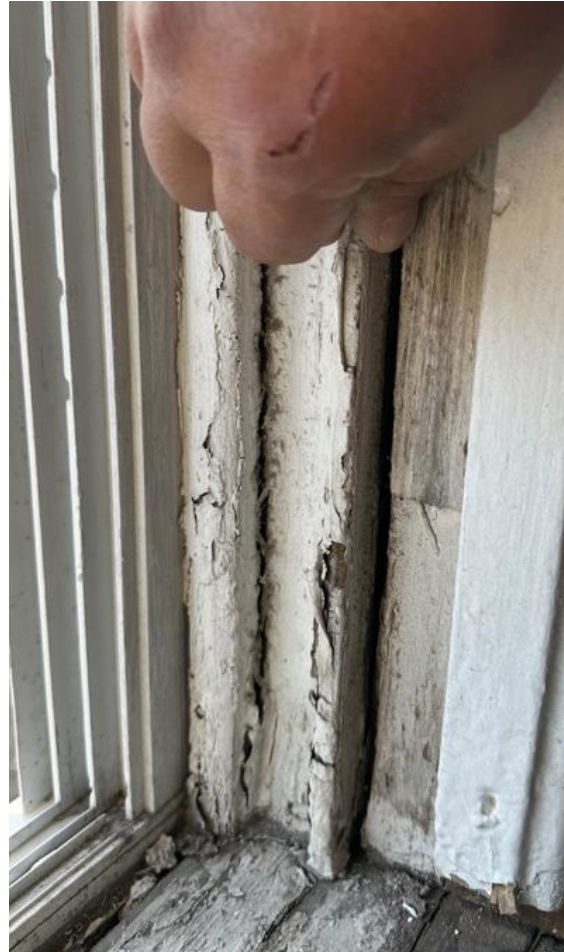
**Tag:** 2-J

**Condition:** Frame is in poor condition. Sashes in poor condition. Significant rot.

**Replacement:** Andersen 400 series 2:2 (SDL) DH window, size to match existing, color: white

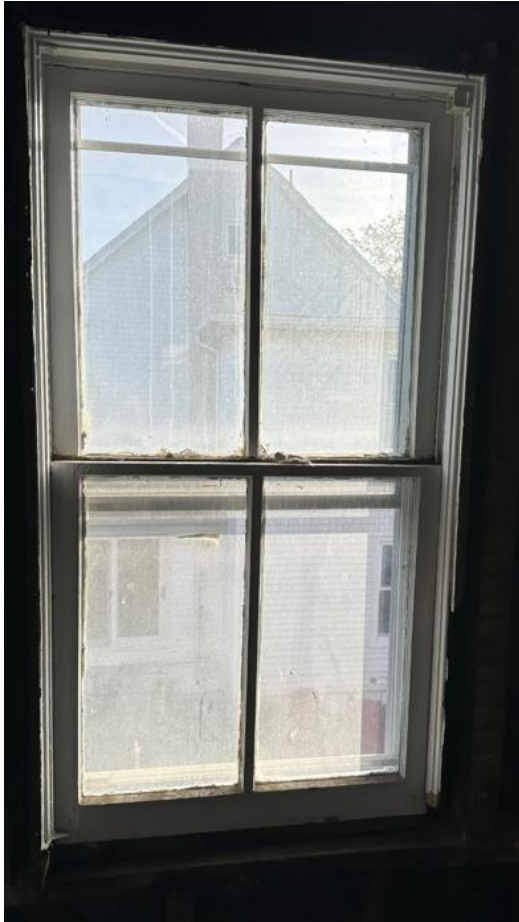
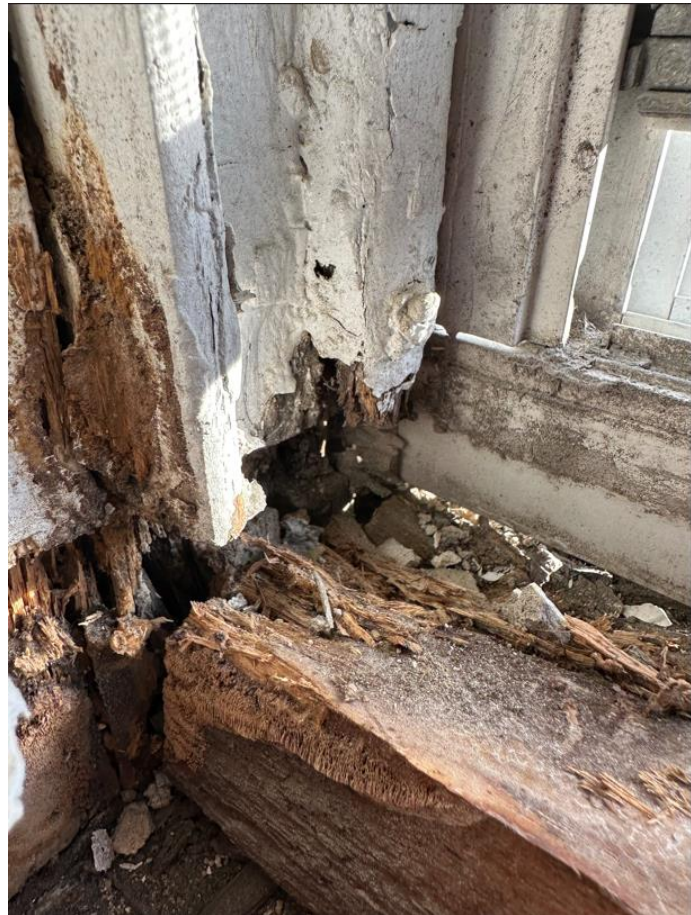
**Tag:** 2-K

**Condition:** Frame is in very poor condition. Requires full reconstruction. Sashes in very poor condition. Require extensive repairs. Poorly maintained, led to significant deterioration.

**Replacement:** Andersen 400 series 2:2 (SDL) DH window, size to match existing, color: white

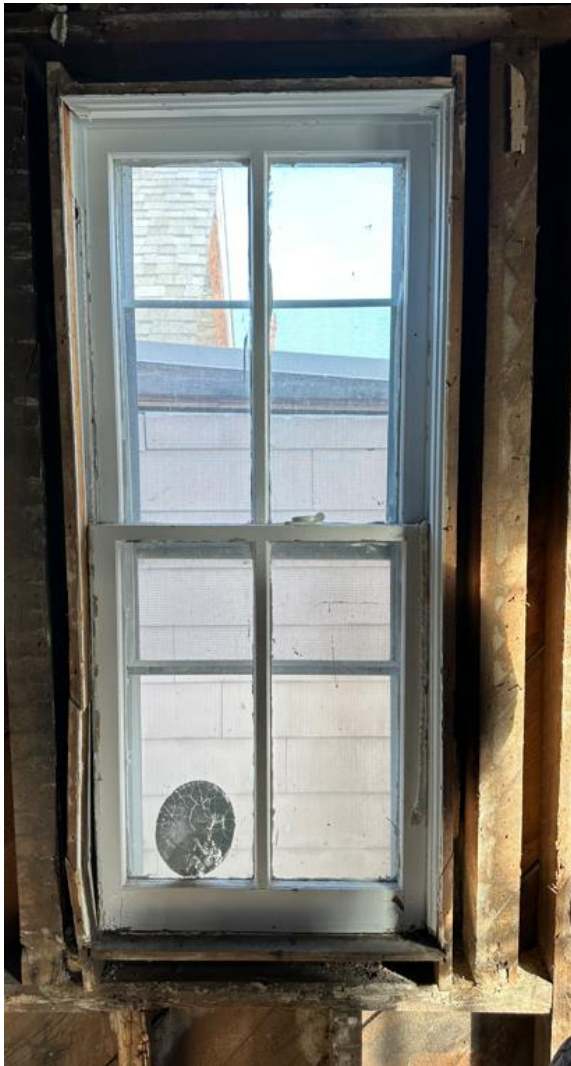
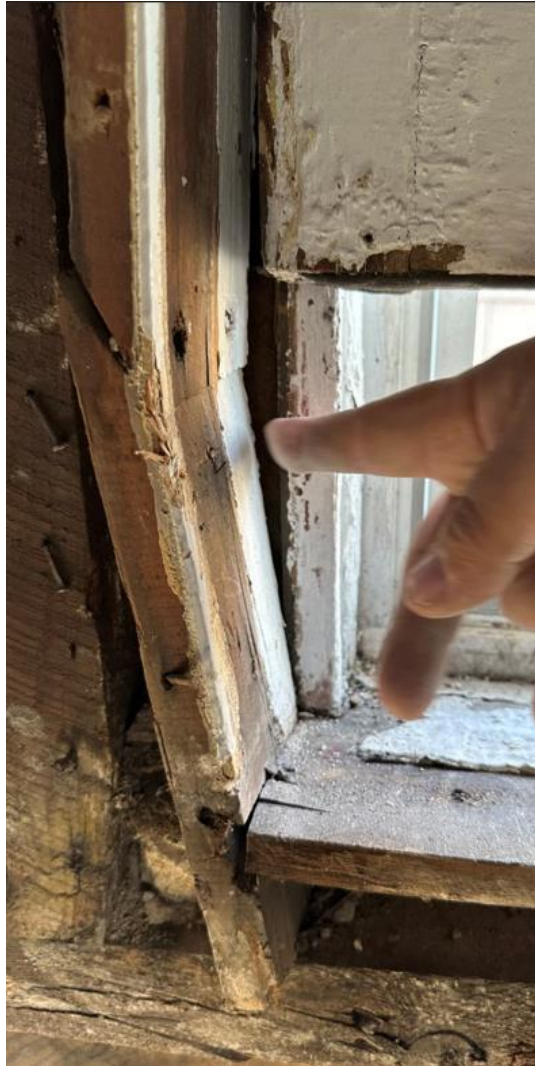
**Tag:** 2-L

**Condition:** Frame is in very poor condition, cracked. Requires full reconstruction. Sashes in very poor condition. Require extensive repairs. Poorly maintained, led to significant deterioration.

**Replacement:** Andersen 400 series 2:2 (SDL) DH window, size to match existing, color: white

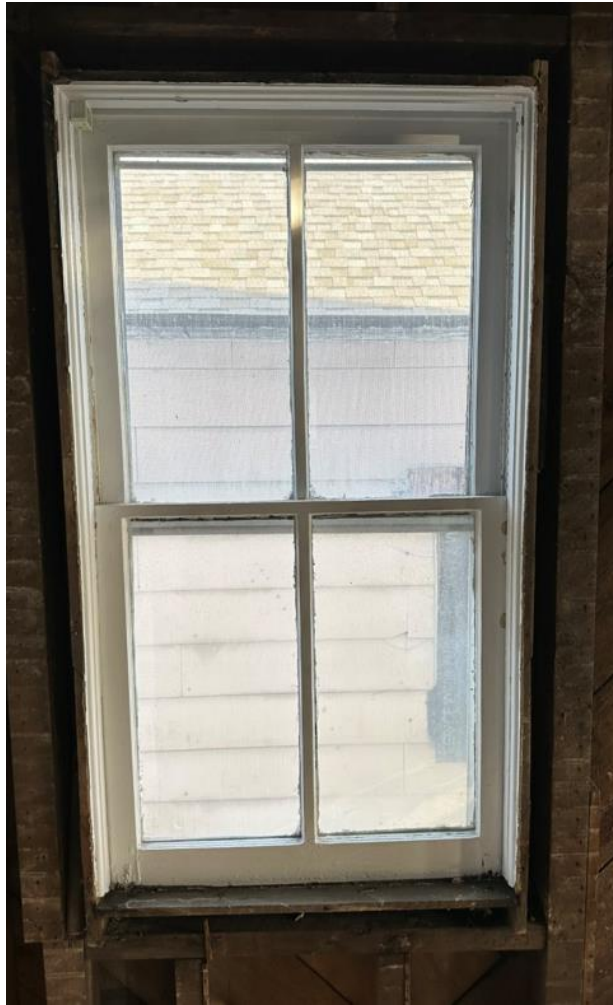
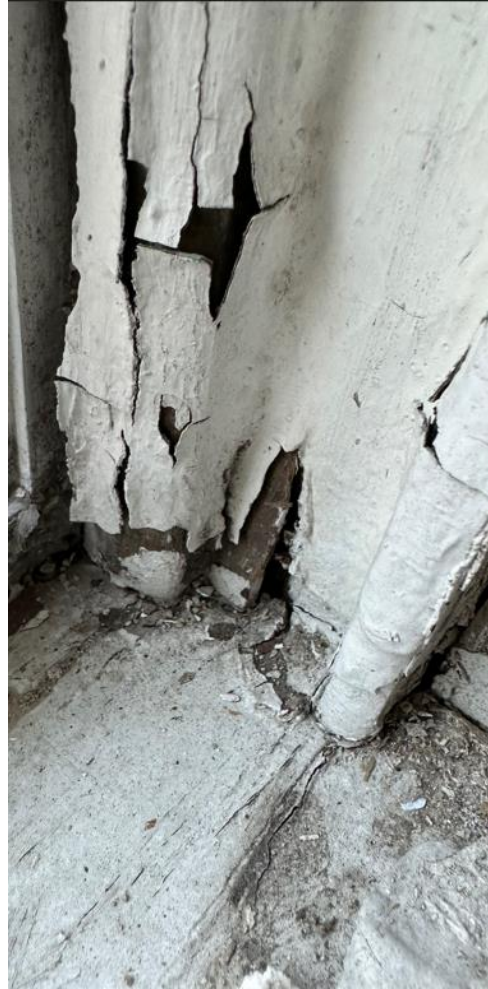
**Tag:** 2-M

**Condition:** Frame is in poor condition. Requires full reconstruction. Sashes in poor condition. Require extensive repairs. Poorly maintained, led to significant deterioration.

**Replacement:** Andersen 400 series 2:2 (SDL) DH window, size to match existing, color: white

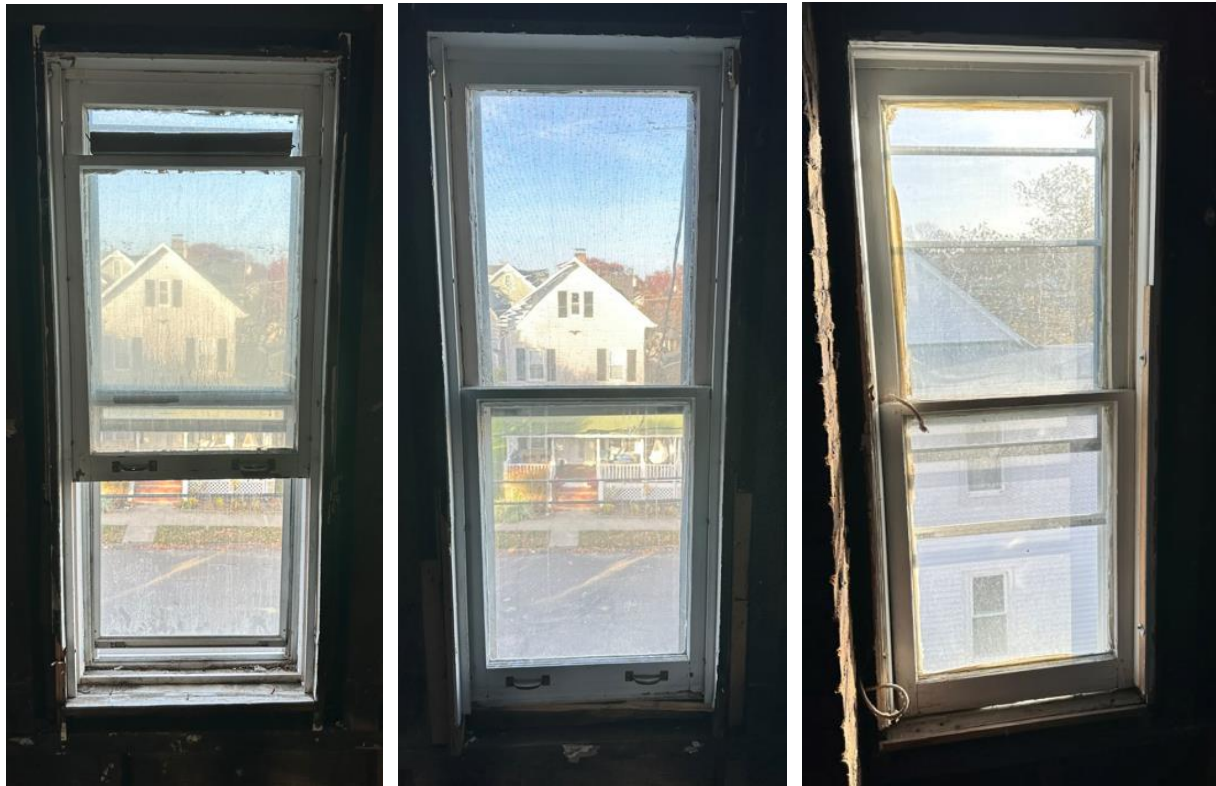
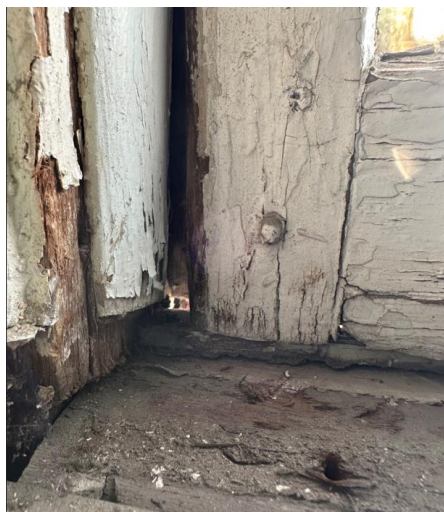
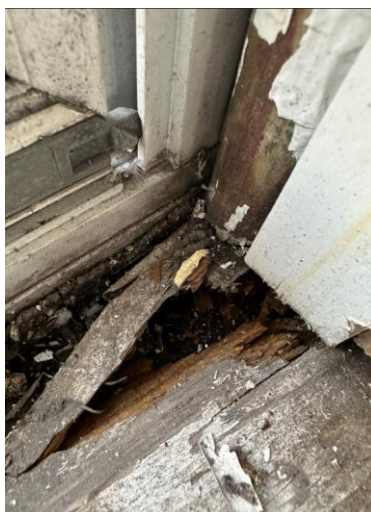
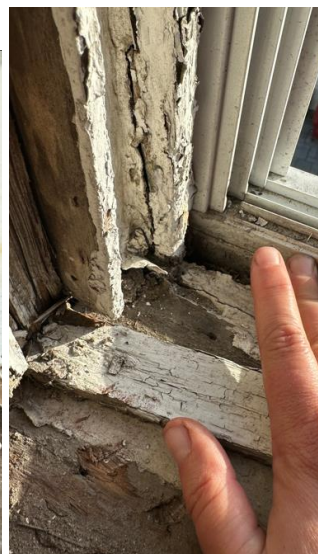
**Tag:** 3-A, 3-B, 3-C

**Condition:** Frame and sashes in very poor condition. Not properly maintained.

**Replacement:** Andersen 400 series 2:2 (SDL) DH window, size to match existing, color: white
