13 April 2022

Following OGNED's meetings before the Historic Preservation Commission (HPC) on 6 & 27 April 2021, three members—Deborah Osepchuk, Lucinda Heinlein, and Jeffery Rudell—were asked by Bernie Haney, to meet and offer feedback to the development team on ways their application (the Plan) could be brought into conformity with the Architectural Design Guidelines (Guidelines). These meetings were similar to the informal weekly Tech Review meetings available to all applicants to the HPC.

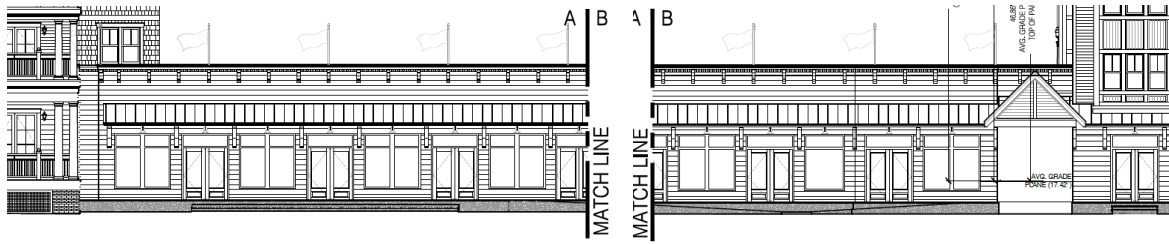
B.10. — **Retail:** Are railings specified at the “elevated sidewalk” that runs in front of the Retail? Specifically, will there be railings at each stair to assist people with mobility needs? If so, please submit a cat/cut for review.

Illustrations B.10.a and B.10.b — East elevations of proposed retail (Sheet A-5) showing elevated “sidewalk/platform” without guard or stair rails (Sheet A-5).

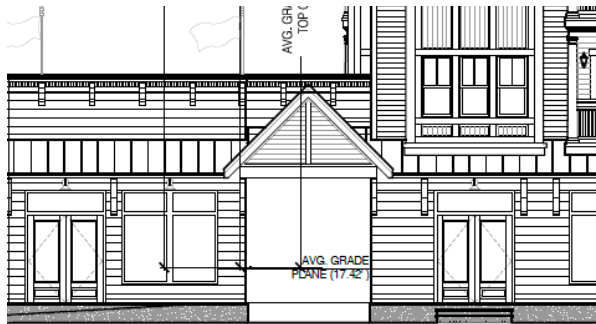
B.11. — Courtyard Corridor: At Tech’s request, OGNED agreed to reconsider the access corridor that leads from the boardwalk to the interior courtyard, to better highlight the access point and make it look more like a feature of the Retail frontage and less like an alley. At present, the pedimented entry has little relationship to the rest of the Retail area or the boardwalk itself. Tech asked OGNED to consider ways to extend that entrance forward (as a pergola or other structure extending toward the boardwalk) to better invite pedestrians into the space. The Plan presented did not activate courtyard access in any way, provided no shade, and seemed “uninviting.” No change to this area is reflected in the current Plan.

Illustration B.11. — East elevation of proposed pediment-topped entry to courtyard corridor (Sheet A-5).

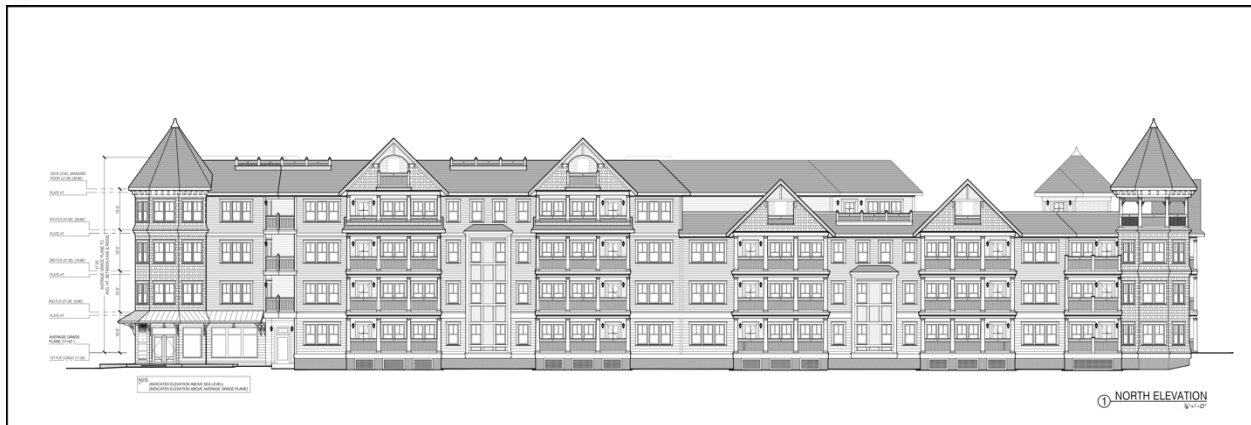
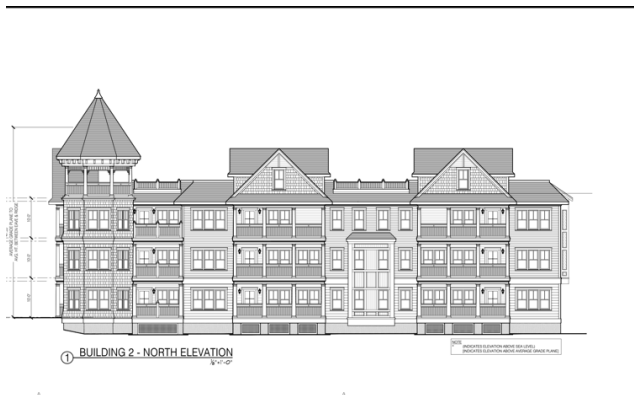
B.14. — **Condominiums:** Tech noted the proposed changes in plane on each of the Condominium buildings was minimal and provided insufficient visual rhythm, presenting instead, as a continuous wall along the north elevations facing Wesley Lake. Given the prominent lakeside location, Tech asked if the elevation of these buildings could better mimic, in scale and massing, individual townhouses.

Illustration B.14.a. — North elevation, Condominium Building One (Sheet A-6).

Illustration B.14.b. — North elevation, Condominium Building One (Sheet A-8).

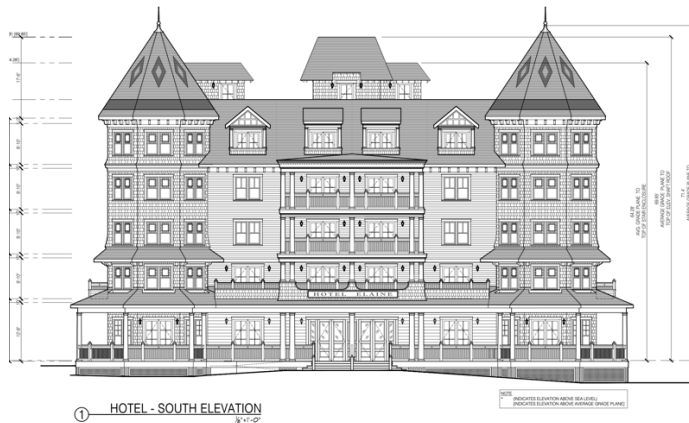
C.3. — **Hotel: Tower Roofs.** The two towers are decorated with over-scaled diamond shapes and wide banding (both created using contrasting roof shingles). Tech found these decorative elements “Disney-esque” in scale and out of character with more nuanced rooftop articulation typical of historic buildings.

Illustration C.3. — South elevation of the Hotel showing proposed diamonds and banding on tower roofs (Sheet A-11).

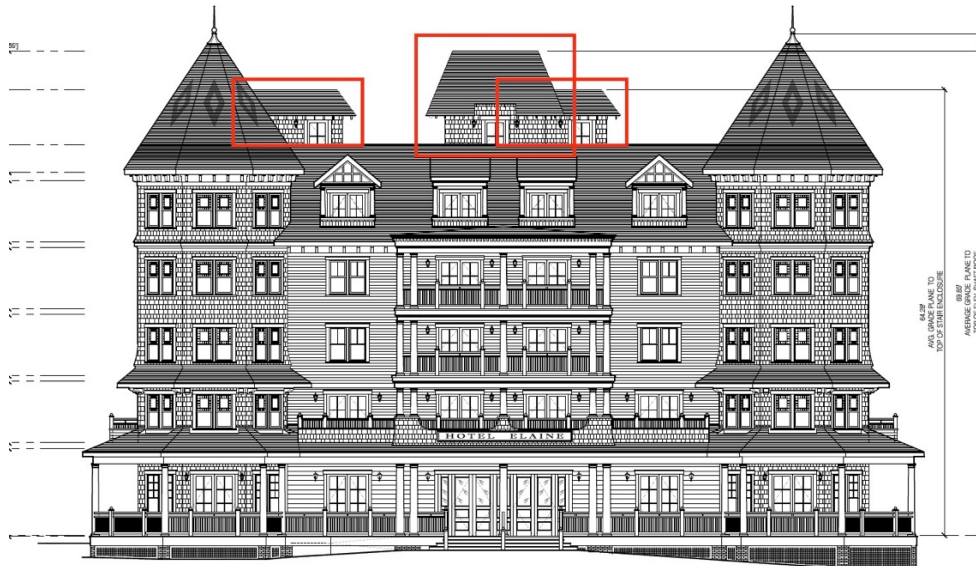
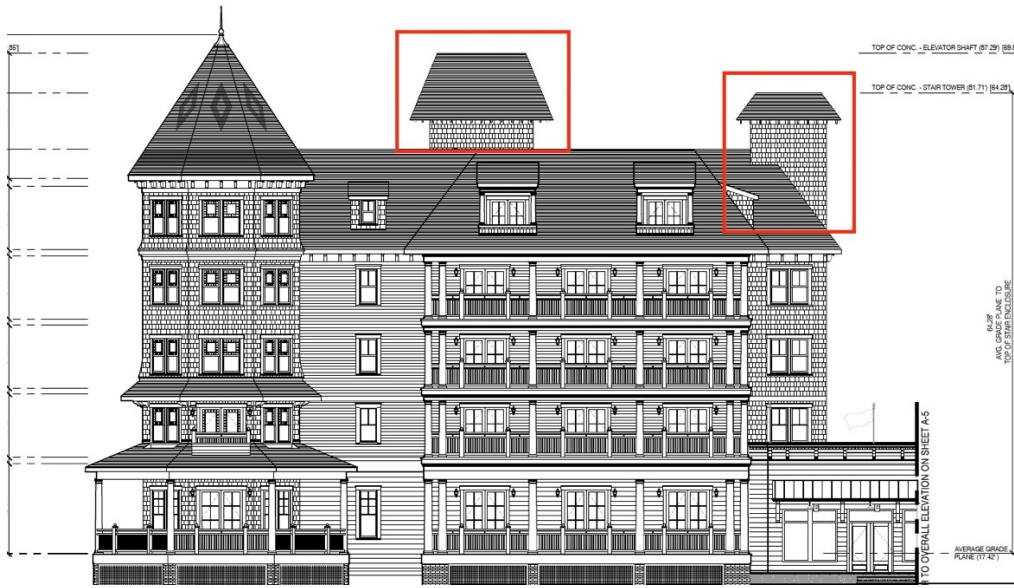
C.4. — Hotel: Roof Projections. A central elevator meant to serve a non-conforming roof deck results in a mechanical projection that rises above the level of the parapet roof. While this projection is not expected to be visible from streets immediately surrounding the Hotel, it will be visible from Ocean Avenue as it approaches the Hotel from the south. Likewise, it will be visible from most of the Ocean Grove beach to the south and east of the building. This projection would not be unnecessary were it not for OGNED’s intention to provide access to a non-conforming roof deck.

Illustration C.4.a. — South roof elevation of the Hotel (Sheet A-11).

Illustration C.4.b. — East roof elevation of the Hotel (Sheet A-11).

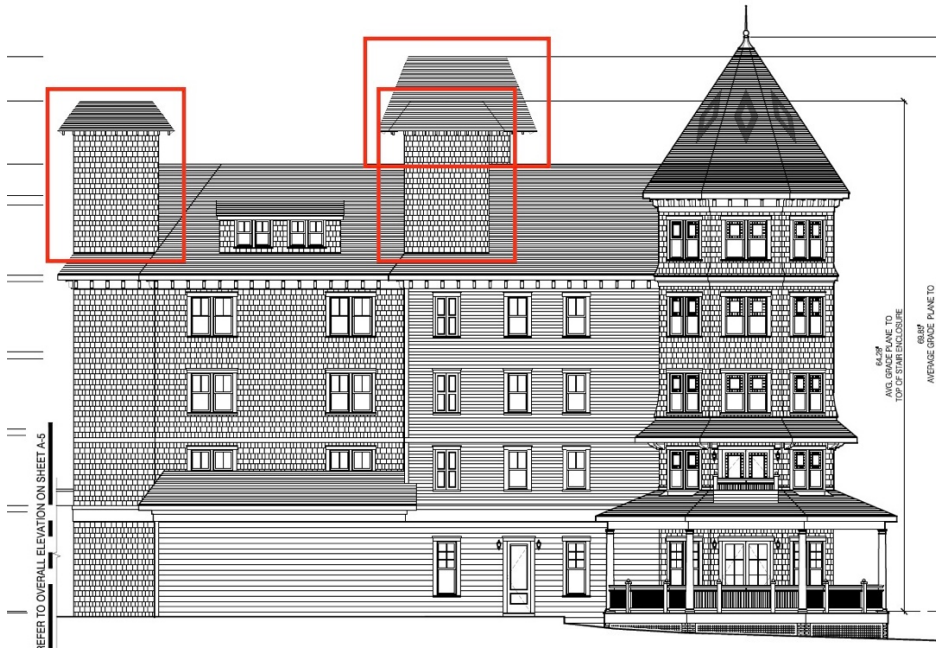
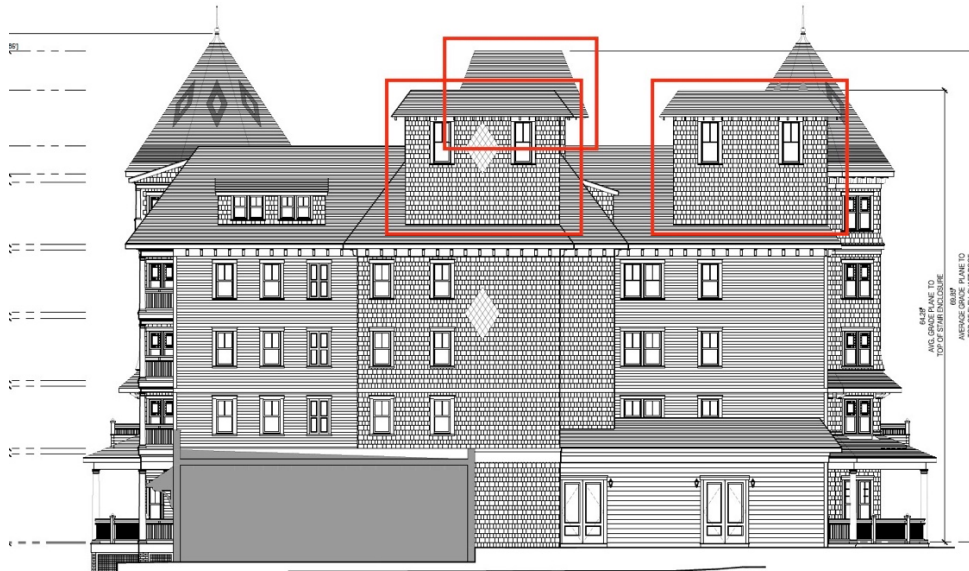
C.5. — **Hotel: Roof Projections.** Two staircase towers also serve the non-conforming roof decks and present similar design non-conformities as a result.

Illustration C.5.a. — North roof elevation of the Hotel (Sheet A-12).

Illustration C.5.b. — West roof elevation of the Hotel (Sheet A-12).

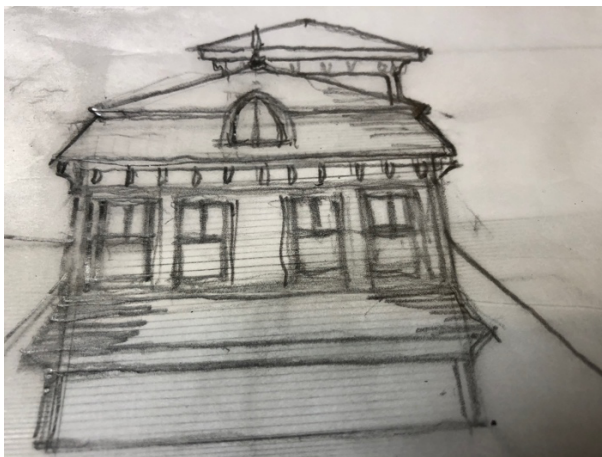
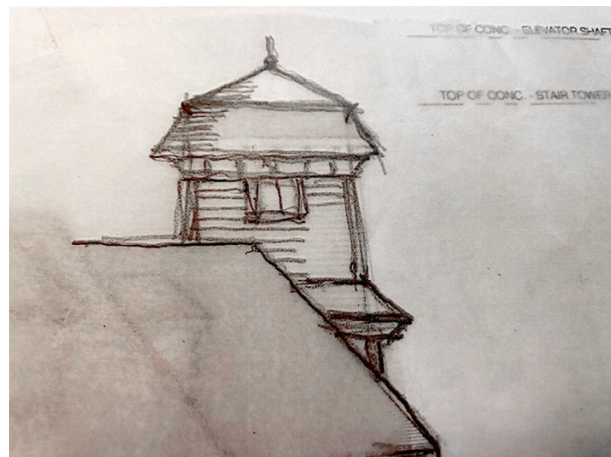
Illustrations C.7.a. and C.7.b. — Sketch of “forced perspective” roof treatments for elevator mechanicals and rooftop stair access.

C.7. — **Hotel: Roof Projections.** Tech shared with OGNED a sketch that showed a possible architectural treatment for disguising the elevator tower using “forced perspective.” In the sketch, a cupola structure hangs over the elevator shaft like an acorn cap, rather than sitting atop it, as with a standard roof. A related sketch showed a similar treatment of staircase towers.

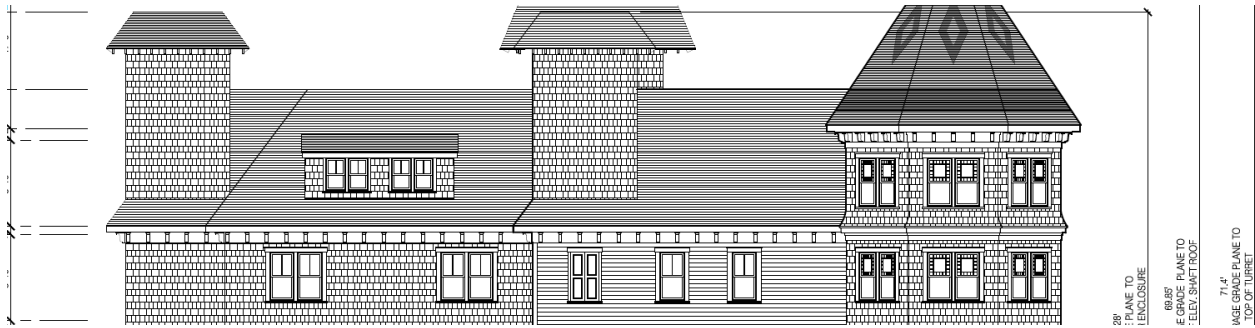
Illustration C.8.d. — Hotel dormers, west elevation, showing two sets of double windows beneath a shed roof (Sheet A-12).

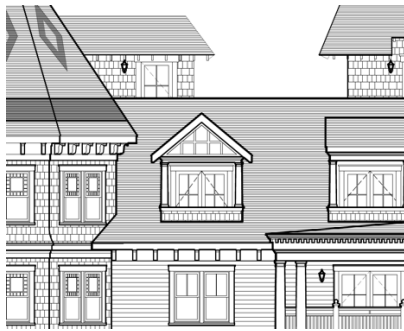
C.9. — Hotel: Dormers. The inclusion of paneling in the dormer gables at the south and east is historically inappropriate. Examples exist of doweled screens and orthogonal lattice in gables, but paneling of this sort is not appropriate.

Illustration C.9. — Hotel dormers, south elevation, showing proposed paneled gable ornamentation (Sheet A-11).

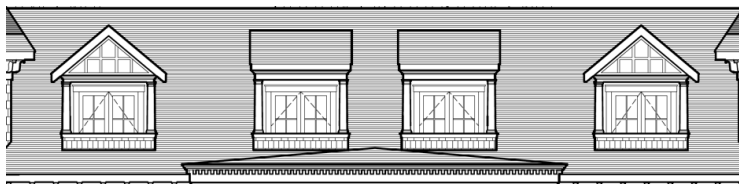
C.10. — Hotel: Dormers. Use of Tuscan columns on roof dormers on the south and east elevations are inappropriate. Properly scaled corbels, similar to those used at the tower balconies below the pent, are more appropriate and would help unify the design through repetition.

Illustration C.10.a. — South elevation of Hotel dormers showing proposed mini-Tuscan columns (Sheet A-11).

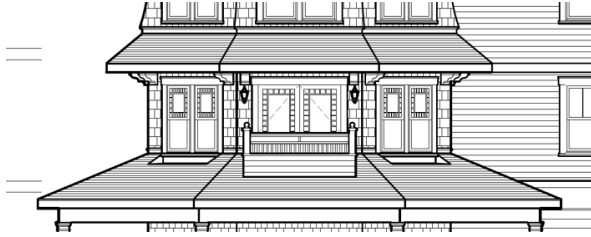
Illustration C.10.c. — East elevation of Hotel tower, second floor, showing corbels suggested for use in dormers (Sheet A-11).

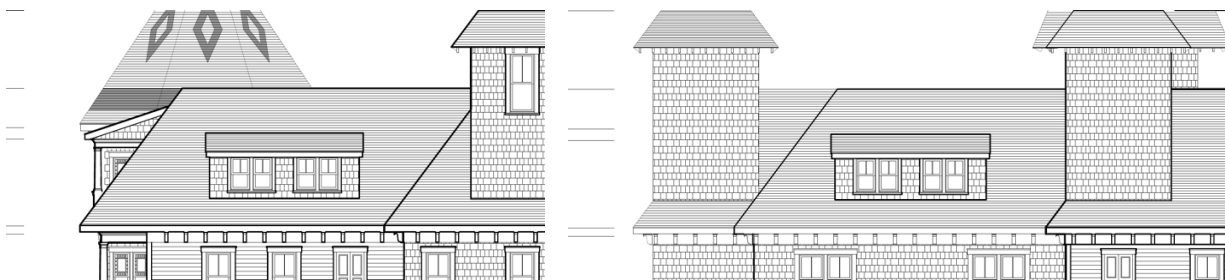
C.11. — **Hotel: Dormers.** The double dormers on the north and west should be changed to conforming individual dormers. Also, these dormers appear smaller than those at the south and east, perhaps due to them containing only windows and not doors. Please clarify.

Illustrations C.11.a. and C.11.b. — The north and west elevations of the Hotel showing proposed, non-conforming, double dormers (i.e., pop-ups) (Sheet A-12).

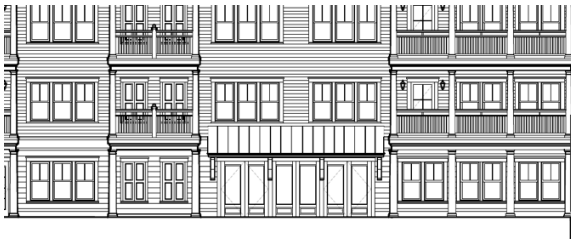
C.13. — **Condominium:** The main entrance to Building One (south elevation) has a non-conforming standing seam roof. (See Guidelines, page 14, 4: “Avoid use of modern standing seam factory painted metal roofing, and shingles of inappropriate historic period color, such as white or green.”)

Illustration C.13. — South elevation of Condominium Building One showing proposed standing seam roof over main building entrance (Sheet A-6).

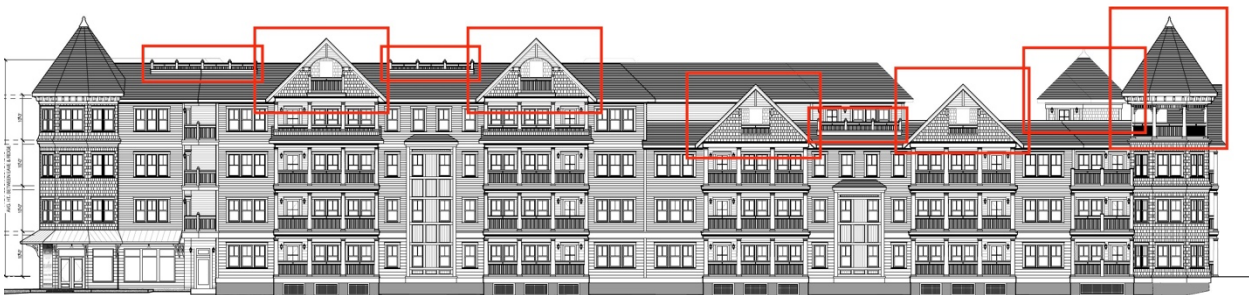
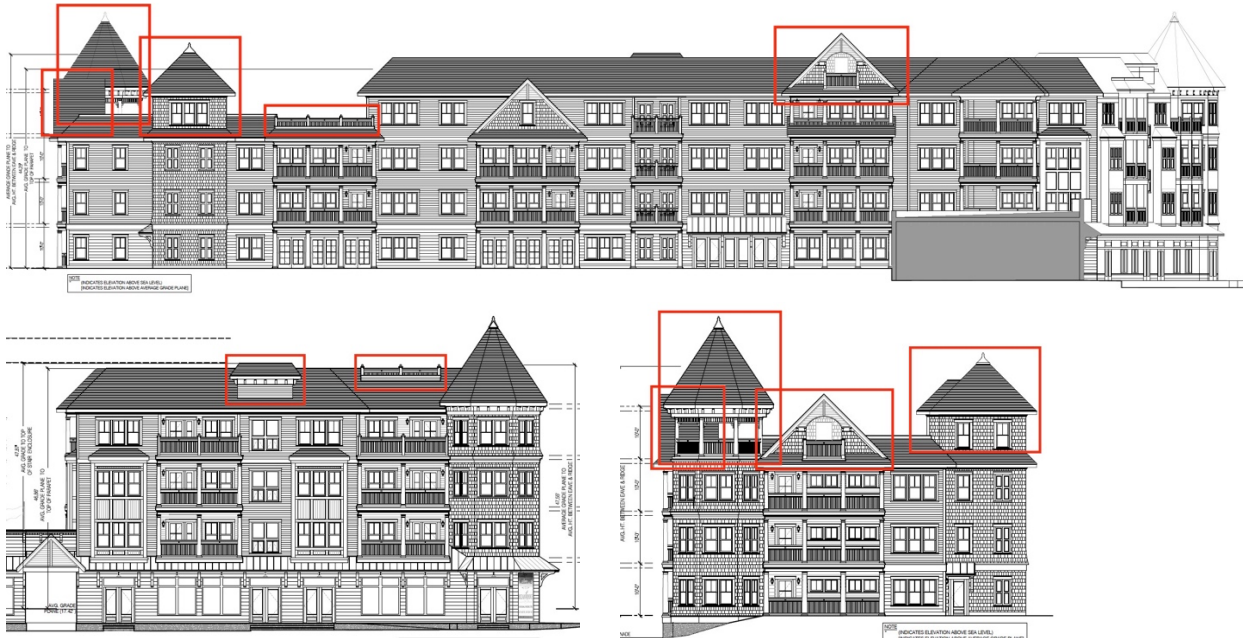
C.14. — **Condominiums:** Rather than strong, historically appropriate, roof forms, the Condominium buildings display disparate architectural elements that fail to unify or strengthen the design. These include a parapet roof meant to suggest a faux-Mansard roof, railing breaks in the parapet with short runs of newel posts and balusters, (that work against the faux-Mansard illusion), stair towers at the east and west elevations that penetrate the parapet, and unusual, non-historic faux-gables with cut-out openings, that further emphasize the non-historic roof treatment.

Illustrations C.14.a., C.14.b., C.14.c., and C.14.d. — The north, south, east, and west elevations of Condominium Building One showing non-conforming faux-gables, balusters and rails, cupola, and stair towers (Sheets

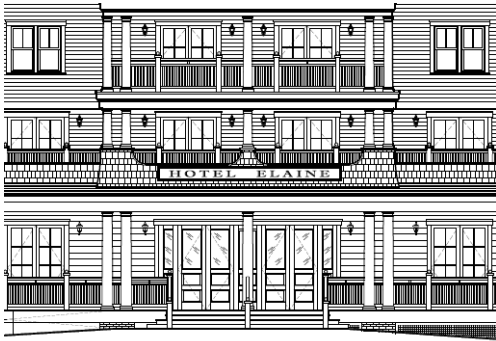
D.1. — **Hotel:** The elevations show main entry doors of the Hotel as two sets of double doors; each $\frac{1}{2}$ -glass with two panels beneath. Tech suggested $\frac{3}{4}$ glass with a single panel beneath would be more historically appropriate and might better delineate the entry. The application is missing the required cat/cut for the doors.

Illustration D.2. — The south elevation (Sheet A-11) showing proposed double set of double $\frac{1}{2}$ doors, with non-conforming single side-light windows to the left and right.

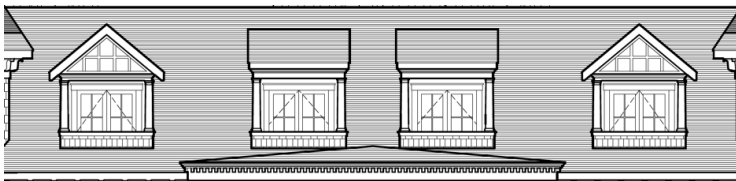
Illustration D.3.a. — South elevation of Hotel dormers showing proposed double doors (Sheet A-11).

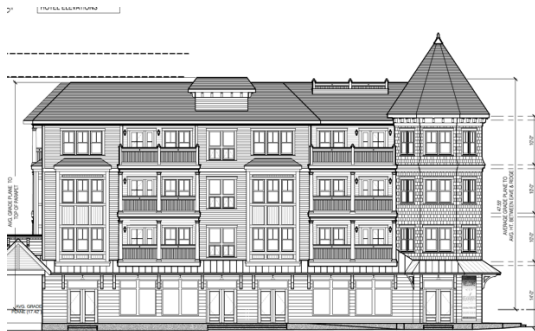
D.4. — **Condominiums:** The east elevation of Building One show single balcony doors flanked by single sidelight windows. Single sidelight windows are inappropriate. These doors should match the single doors found elsewhere on Building One and Building Two.

Illustration D.4. — East elevation of Condominium Building One (Sheet A-5) showing single balcony doors with non-conforming single side-light windows on each of the six balconies. These balcony doors should match single balcony doors on other elevations and should not include side-light windows.

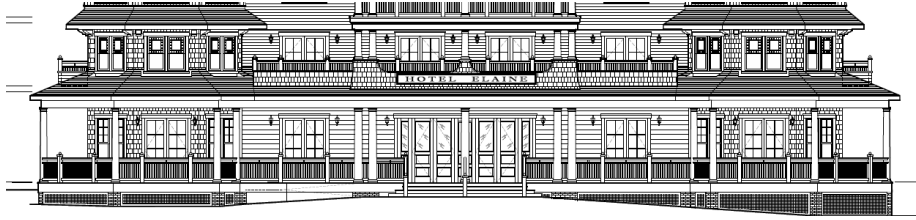
Illustration E.3.a. — First-floor, south elevation of the Hotel showing inappropriate Colonial Revival windows (Sheet A-11).

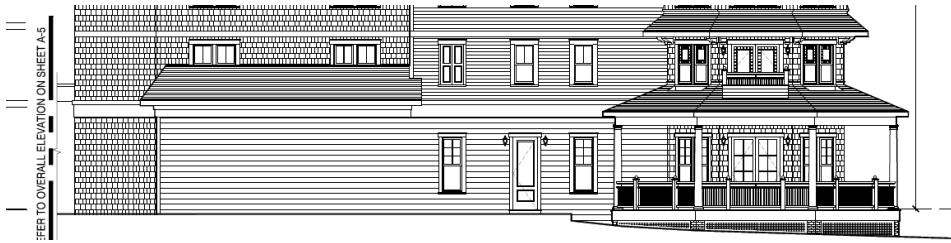
Illustration E.3.b. — First floor, west elevation of the Hotel showing inappropriate Colonial Revival windows (Sheet A-12).

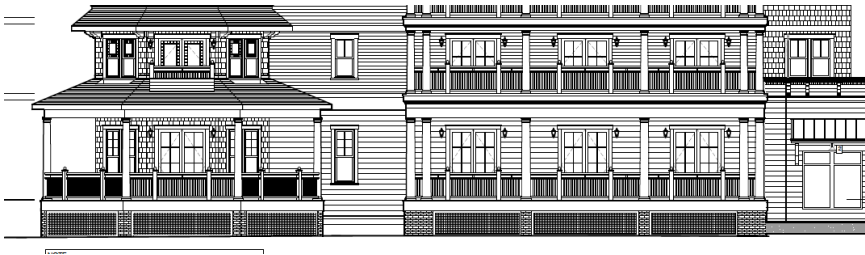
Illustration E.3.c. — First floor, east elevation of the Hotel showing inappropriate Colonial Revival windows (Sheet A-12).

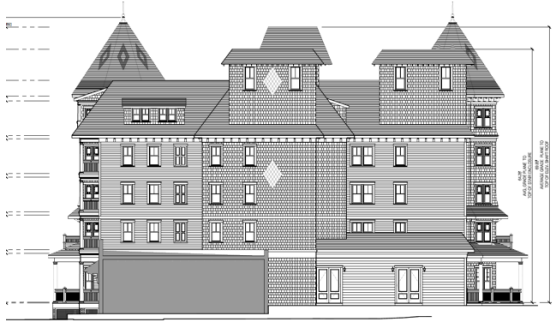
Illustration E.5. — North elevation of Hotel (Sheet A-12), showing upper staircase towers with two windows each.

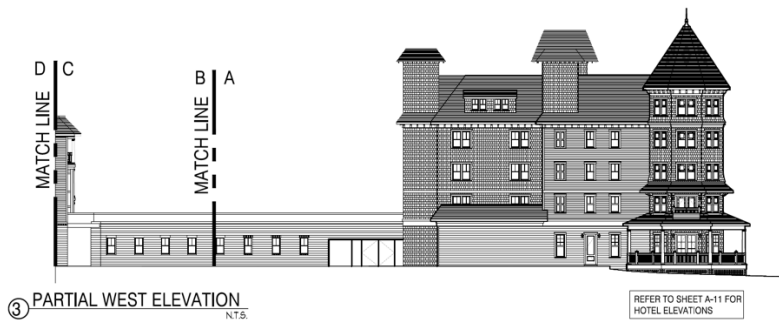
Illustration E.6. — West elevation showing proposed rear fenestration of Retail shops (Sheet A-5).

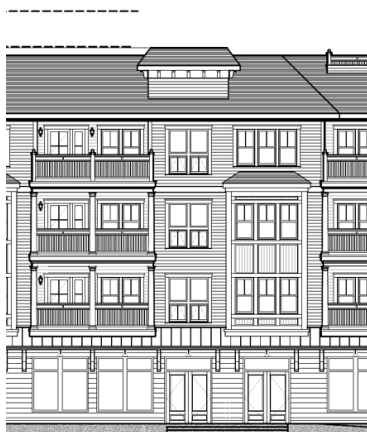
E.7. — **Condominiums:** On the east elevation of Building One, a stack of double windows in the stairwell are configured in such a way as to appear to be 1/2. This oddity gives the impression that 2/1 windows, evident elsewhere on the elevation, have been installed upside down. If these are proposed awning windows, awning windows are not appropriate to a Queen Anne design. Tech suggests a conforming solution be developed to replace this fenestration.

Illustration E.7. — Detail of staircase windows (center) configured in such a way as to suggest 2/1 windows have been installed upside down (Sheet A-5).

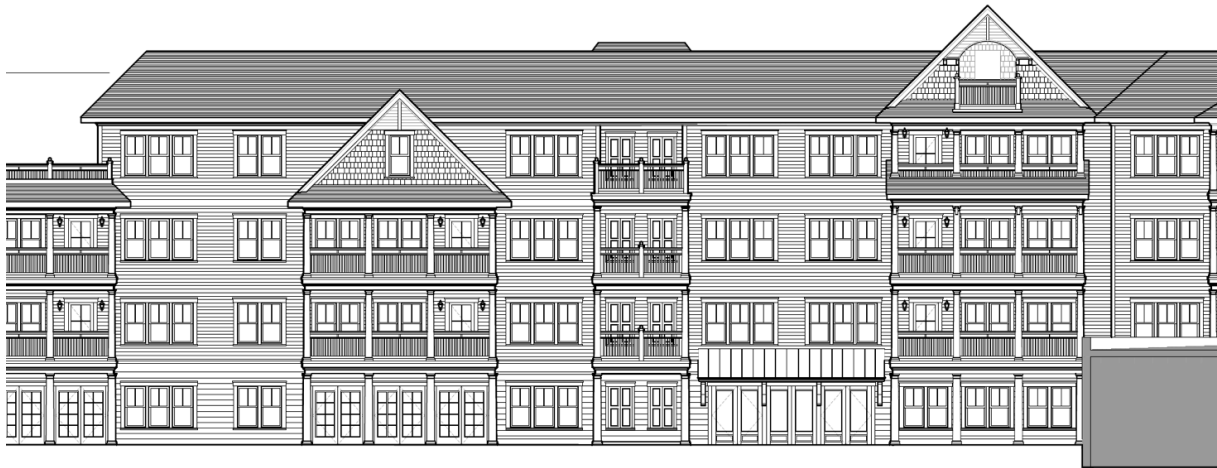
Illustration E.8.b. — Detail of south elevation of Condominium Building Two showing stacked courses of double and triple windows in non-historic fenestration patterns.

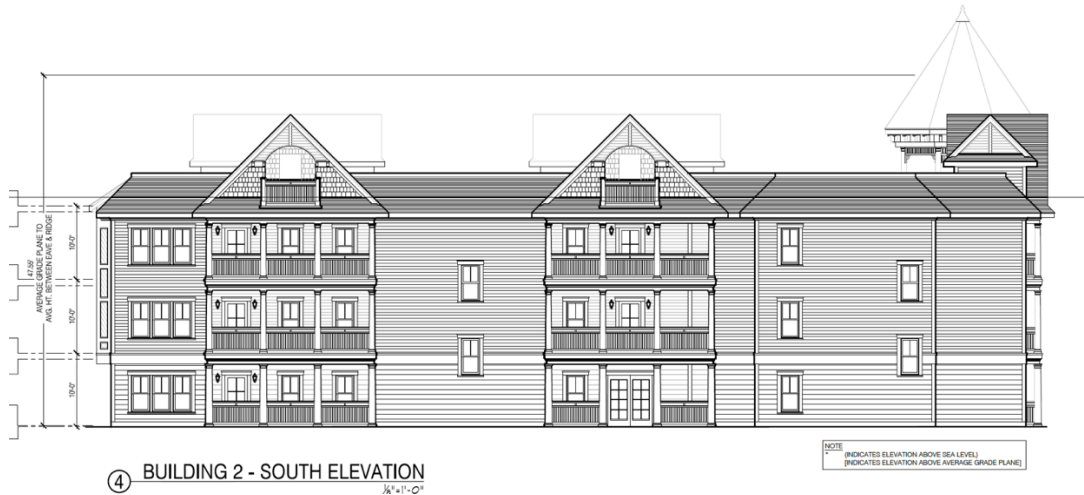
Illustration E.9. — South elevation of Condominium Building Two showing oddly spare single-window fenestration (Sheet A-8).

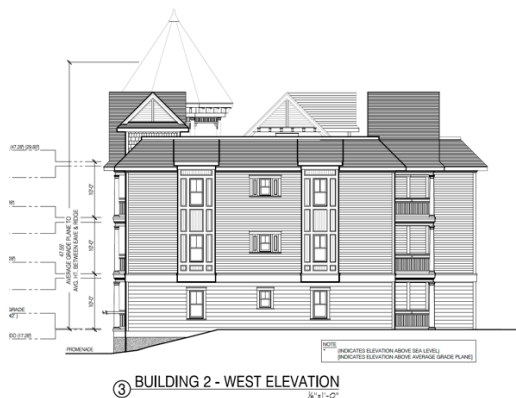
E.10. — **Condominiums:** Tech found the west elevation of Building Two particularly unsuccessful with two floating projections hanging down from shed roofs. These projections end abruptly above single windows at the first story. The projections include single windows on each floor (with the rest of the projection covered in vertical-paneled frames). Single windows on projections of this type are non-historic. In the center of the west elevation are three under-sized windows: one with traditional trim, the other two flanked by more panels and extended crowns. The west elevation will be prominent not only to residents in properties to the west of the development and pedestrians walking along Wesley Lake, but also to traffic traveling east down Lake Avenue on the Asbury side of Wesley Lake. Tech considers this elevation under-designed, un-historic, and in need of redesign.

Illustration E.10. — West elevation of Condominium Building Two (Sheet A-8).

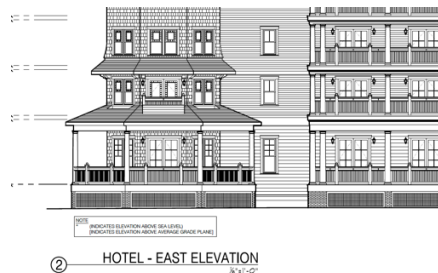
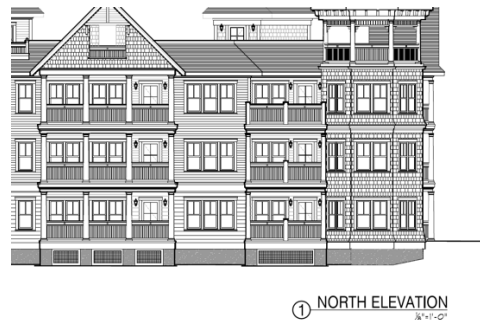
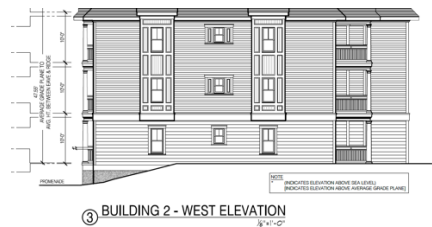
F.1. — **Hotel & Condominium Siding.** The Plan proposes cladding the Hotel with Hardie Plank with two different clapboard reveal dimensions: wide on the first story and narrower on the upper stories. Mixing clapboard reveal sizes is sometimes found on historical examples, but only rarely, and only to highlight important architectural features. No such highlighting of architectural features is present in the proposed Plan. Uniform dimensions of clapboard reveals should be used, instead.

Illustration F.1.a. — East elevation of the Hotel showing proposed clapboard reveal at first floor (wide) and upper floors (narrow) (Sheet A-11).

Illustration F.1.b. — North elevation of Condominium Building One showing proposed clapboard reveal at first floor (wide) and upper floors (narrow) (Sheet A-6).

Illustration F.1.c. — West elevation of Condominium Building Two showing proposed clapboard reveal at first floor (wide) and upper floors (narrow) (Sheet A-8).

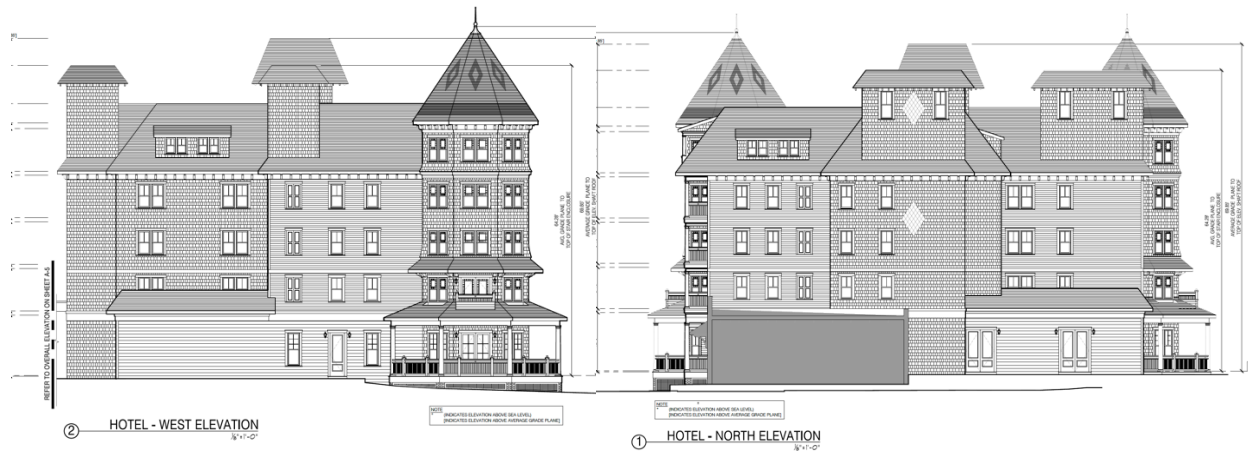
Illustrations F.2.a. and F.2.b. — The west and north elevation of the Hotel showing secondary planes covered in shingles (Sheet A-12).

F.3. — **Hotel: Siding.** Banding is present in the siding between the first and second story (a prominently sized band) and between the second and third story (a modestly sized band), however it is missing between the third and fourth story. This missing banding is especially noticeable on the west and north elevations. This should be addressed. (See illustrations F.2.a. and F.2.b., above.)

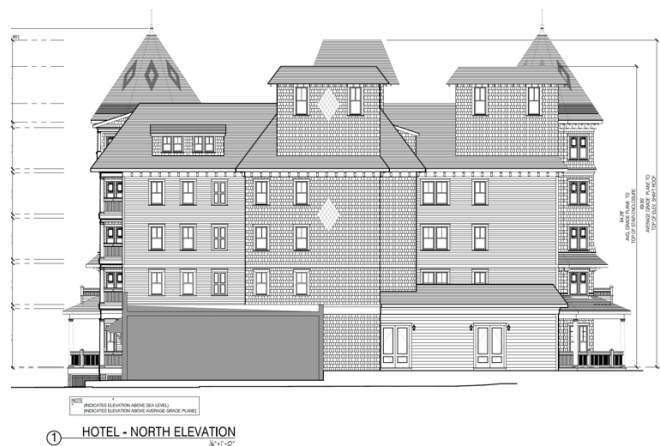
Illustration F.4. — North elevation of the Hotel showing over-sized diamond patterns in shingled cladding. (Sheet A-12).

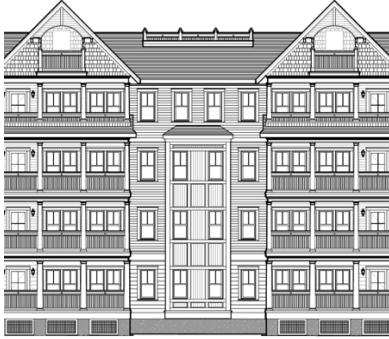
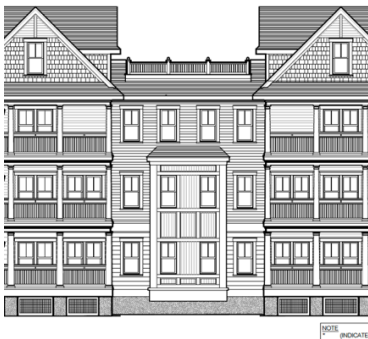
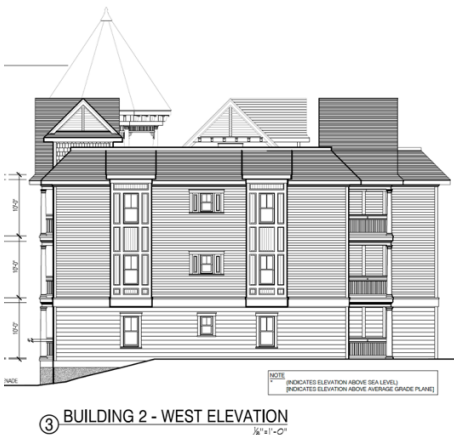
Illustration F.5.a. — Detail of north elevation, Condominium Building One showing paneled areas between windows on projection between balconies (Sheet A-6).

Illustration F.5.b. — Detail of north elevation, Condominium Building Two, showing paneled areas between windows on projection between balconies (Sheet A-8).

Illustration F.5.c. — Detail of west elevation, Condominium Building Two, showing paneled areas between windows on projections (Sheet A-8).

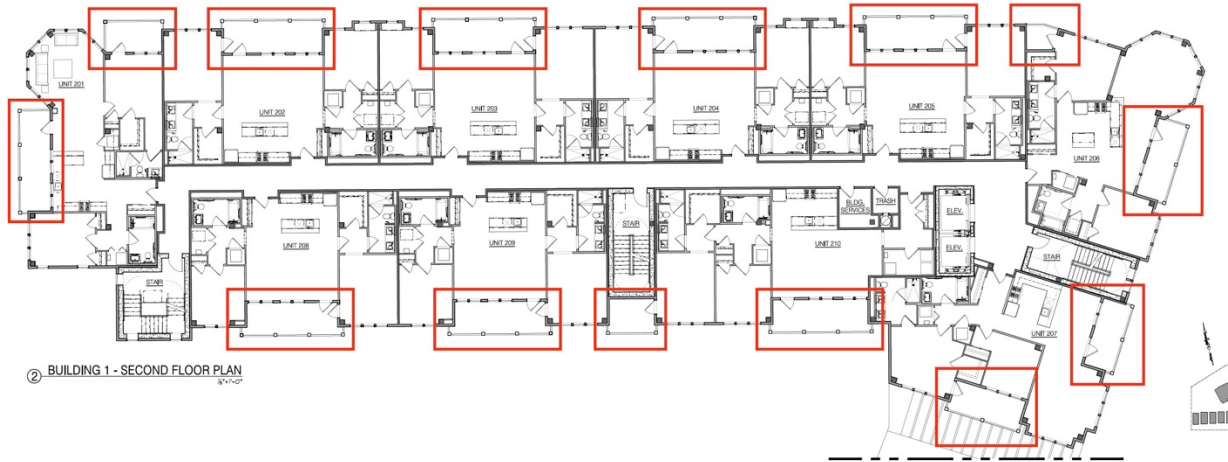
Illustration G.4.a. — Second floor plan of Condominium Building One showing hybrid inset balconies at all four elevations (Sheet A-2).

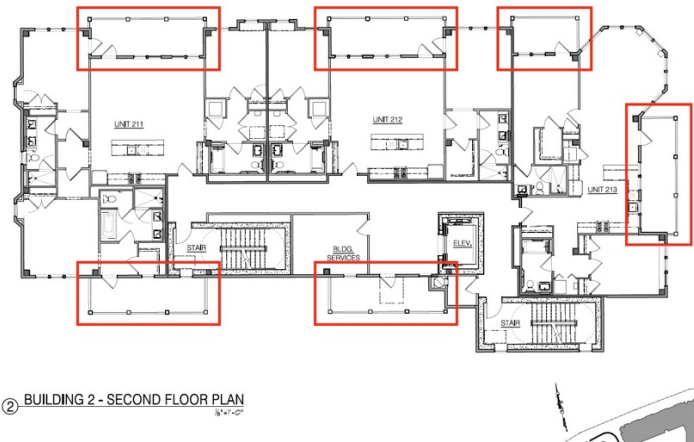
Illustration G.4.b. — Second floor plan of Condominium Building Two showing hybrid inset balconies along the north, south, and east elevations (Sheet A-7).

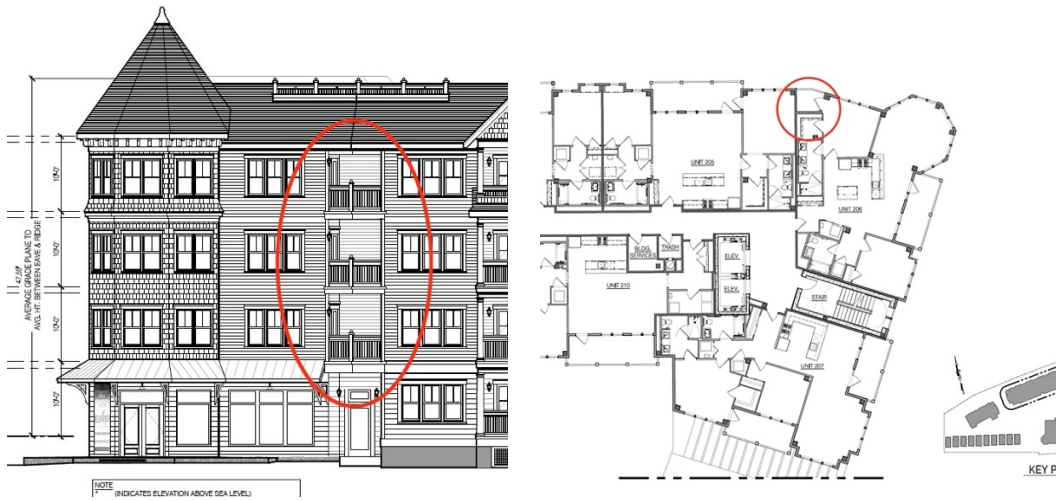
G.5. — **Condominiums:** At the north elevation, just west of the Building One tower, above the north access door, are a row of inset-balconies. These balconies occur at the point where the building jogs southwest along Wesley Lake. These balconies are five-sided, due to a bend in their railings, have no windows, single doors, and no lighting. They are non-historic in character, awkward in size and placement, and differ in every way from any other balcony in the project. Tech recommends they be reconsidered or eliminated.

Illustrations G.5.a. and G.5.b. — Detail of northeast corner of Condominium Building One showing windowless mini-balconies above the north building access door (Sheet A-6). These balconies are circle in the second-floor plan, at right (Sheet A-2).

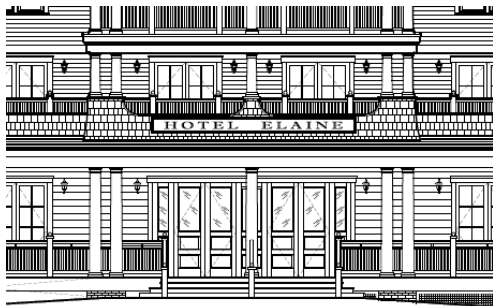
H.1. — **Hotel:** The main entrance stair of the Hotel is bisected by a singled porch column yet flanked by double porch columns. Elimination of the single column is recommended to better frame the entrance.

Illustration H.1. — Hotel entrance flanked by double columns with single column bisecting the entry area (Sheet A-11).

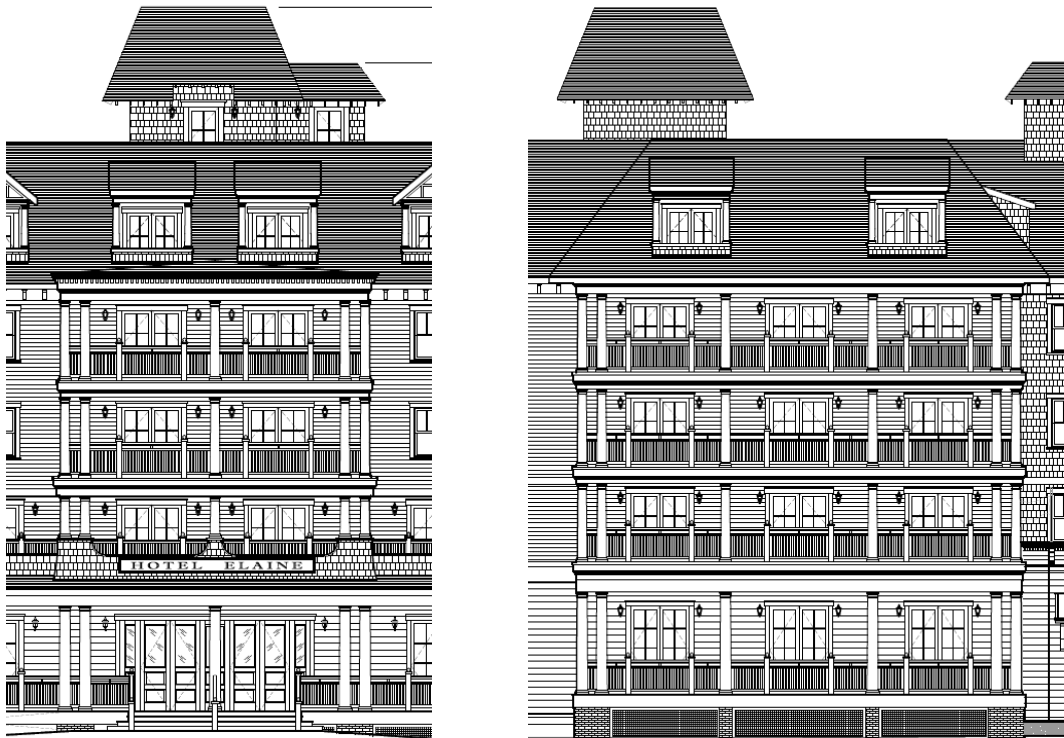
Illustration H.2.a. and H.2.b. — Details of the balcony stacks at the south and east elevation of the Hotel showing double and single columns and newels (Sheet A-11).

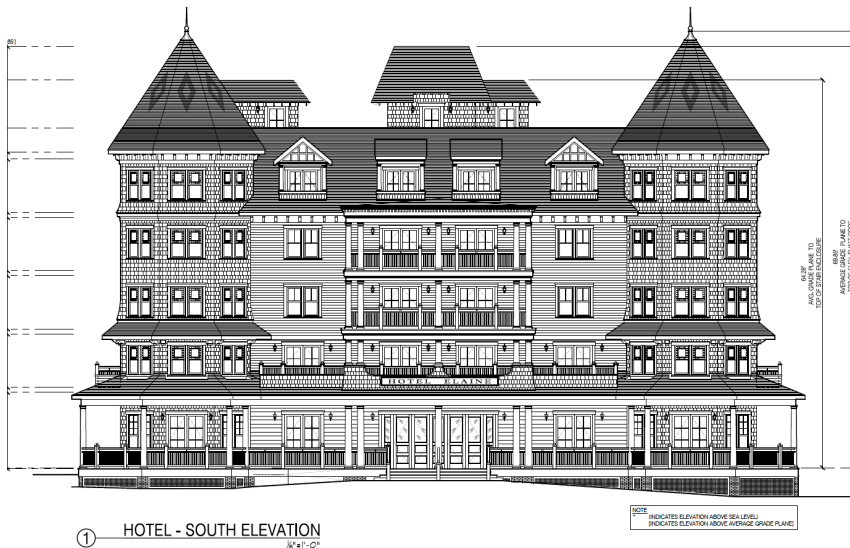
Illustration H.3. — Roof tile patterns showing oversized diamonds and banding (Sheet A-11).

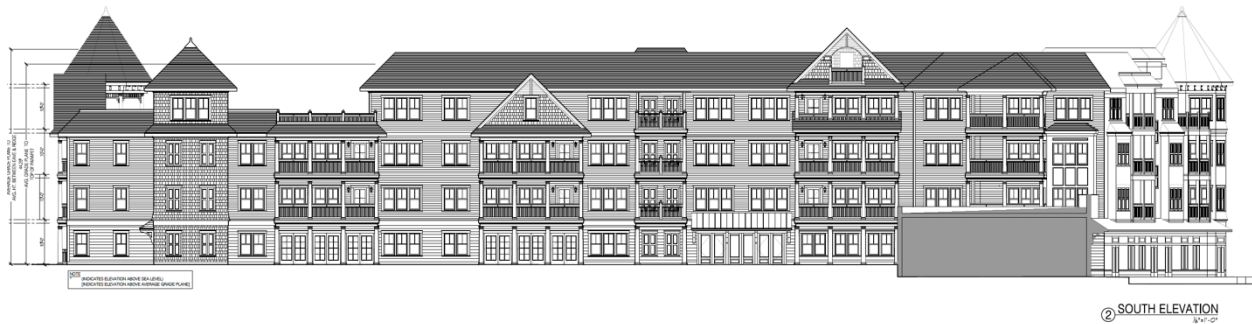
Illustration H.7. — South elevation of Condominium Building One showing Tuscan columns without plinths at the first floor (Sheet A-6).

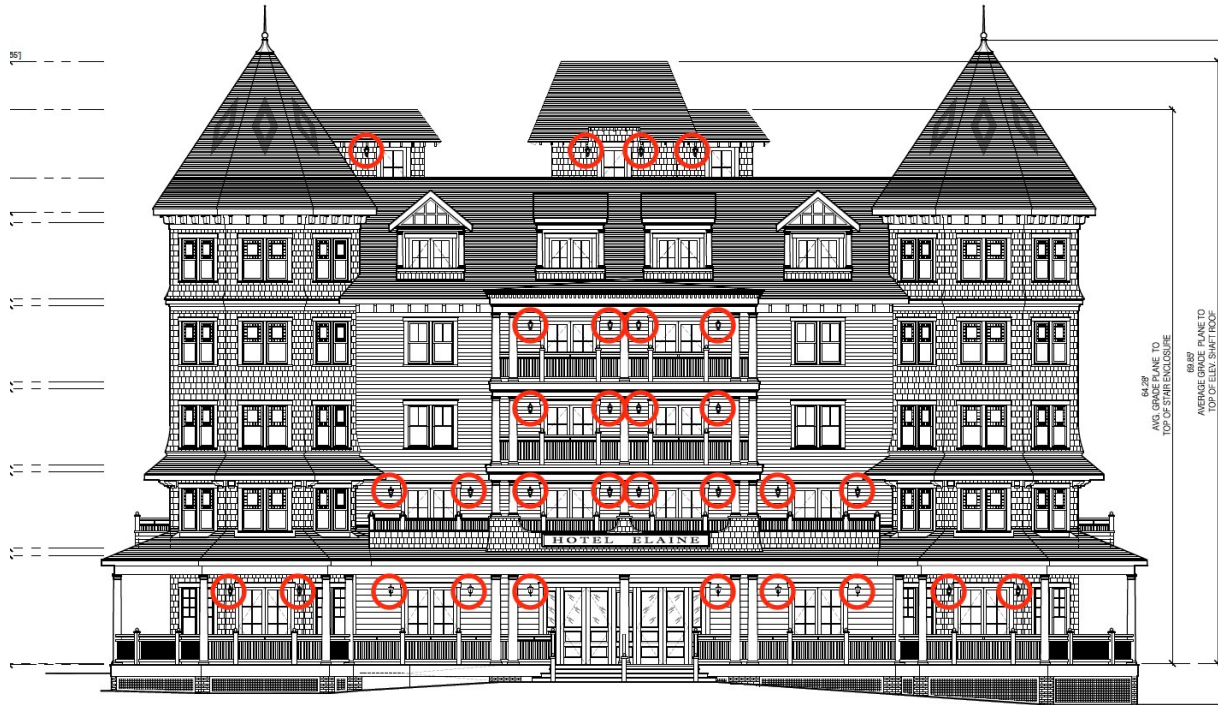
I.4. — **Hotel:** The south elevation of the Hotel indicates thirty (30) lanterns, including four on the roof projections, with an additional twenty-eight (28) lanterns on the east elevation, facing the boardwalk. In contrast, the west elevation shows only six (6) lanterns. Tech considers the number of proposed lights excessive to a degree that is typically modern and recommends that lighting at the south and east elevations be reconsidered.

Illustration I.4.a. — South elevation of the Hotel showing thirty (30) proposed lantern fixtures (Sheet A-11).

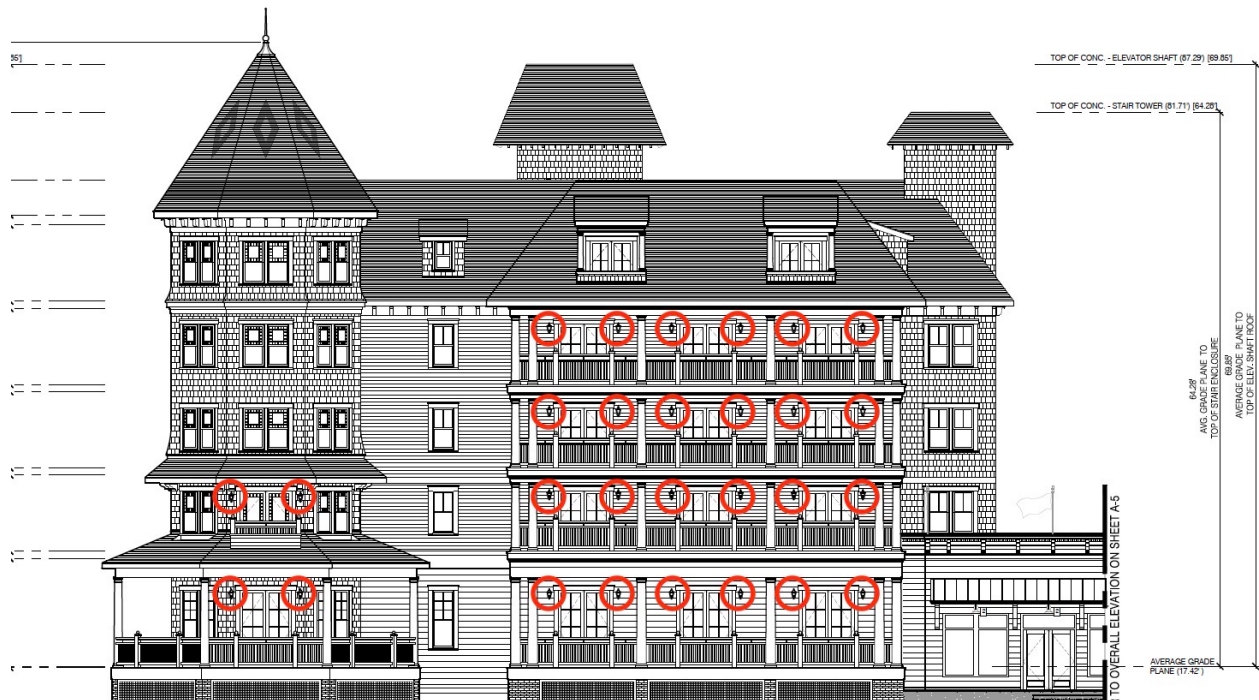
Illustration I.4.b. — East elevation of the Hotel showing twenty-eight (28) proposed lantern fixtures (Sheet A-11).

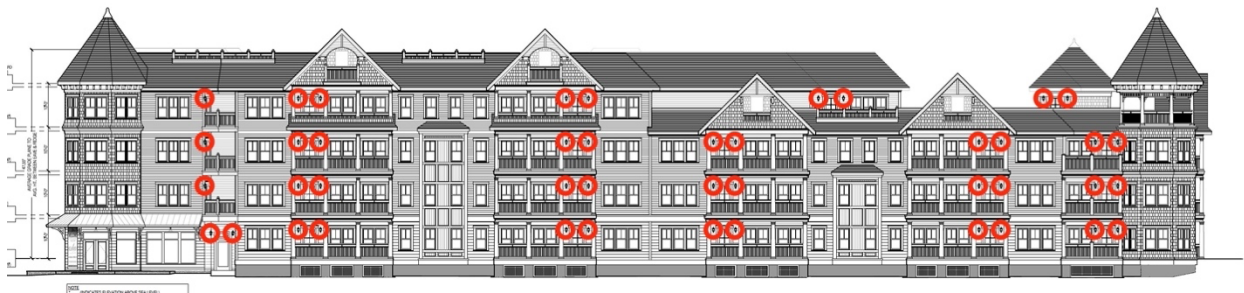
Illustration I.8.a. — North elevation of Condominium Building One showing lighting (most of which entails two light fixtures flanking single doors onto balconies) (Sheet A-6).

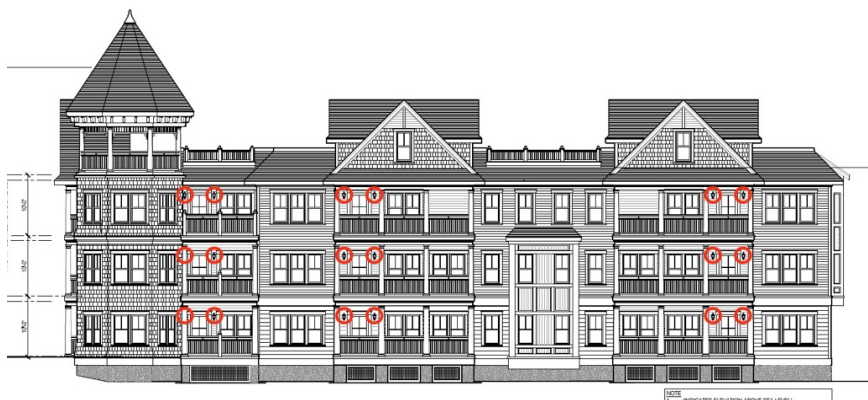
Illustration I.8.b. — North elevation of Condominium Building Two showing lighting (all of which entails two light fixtures flanking single doors onto balconies) (Sheet A-8).

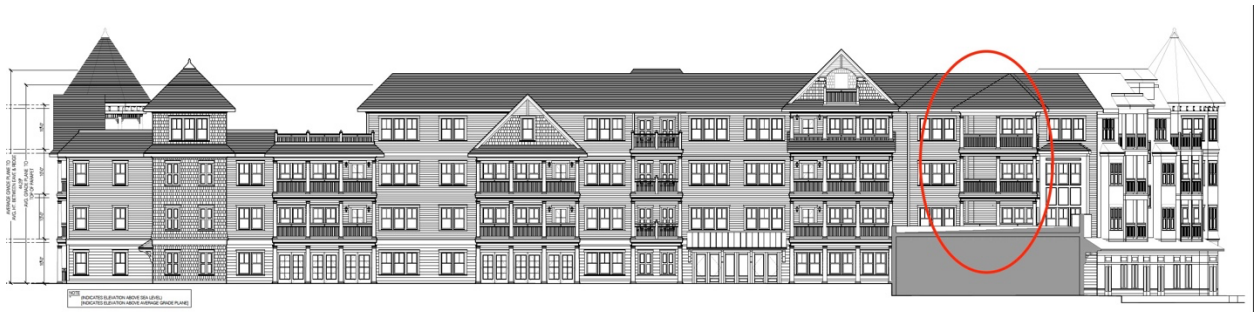
I.10. — **Condominiums:** The lighting, while excessive, also appears inconsistent (e.g., no lighting is indicated on Condominium Building One, south elevation, in the stack of balconies directly above the Retail space).

Illustration I.10. — South elevation of Condominium Building One showing balconies with no lighting indicated.
