13 April 2022

Following OGNED's meetings before the Historic Preservation Commission (HPC) on 6 & 27 April 2021, three members—Deborah Osepchuk, Lucinda Heinlein, and Jeffery Rudell—were asked by Bernie Haney, to meet and offer feedback to the development team on ways their application (the Plan) could be brought into conformity with the Architectural Design Guidelines (Guidelines). These meetings were similar to the informal weekly Tech Review meetings available to all applicants to the HPC.

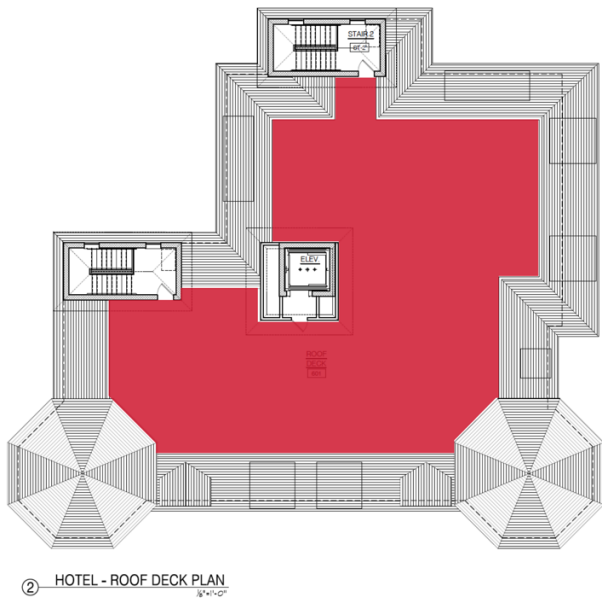
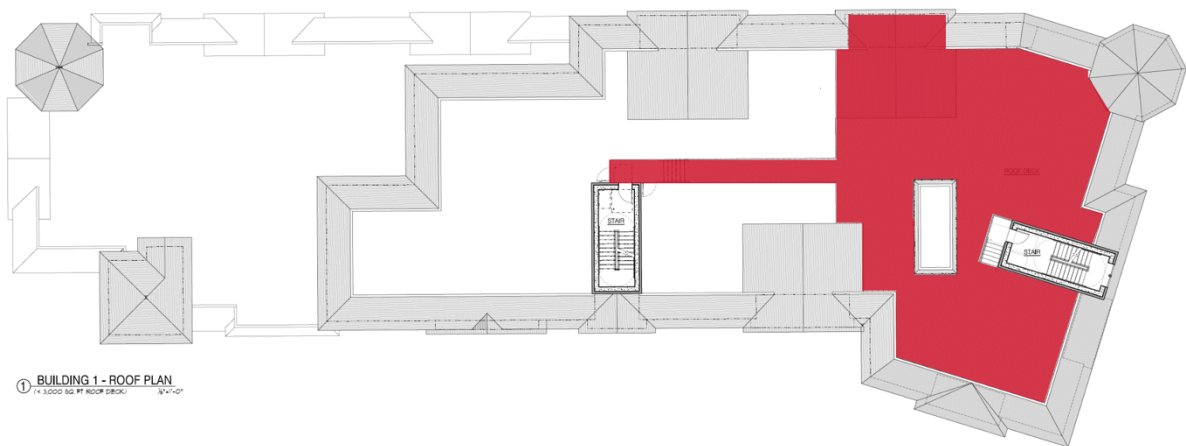
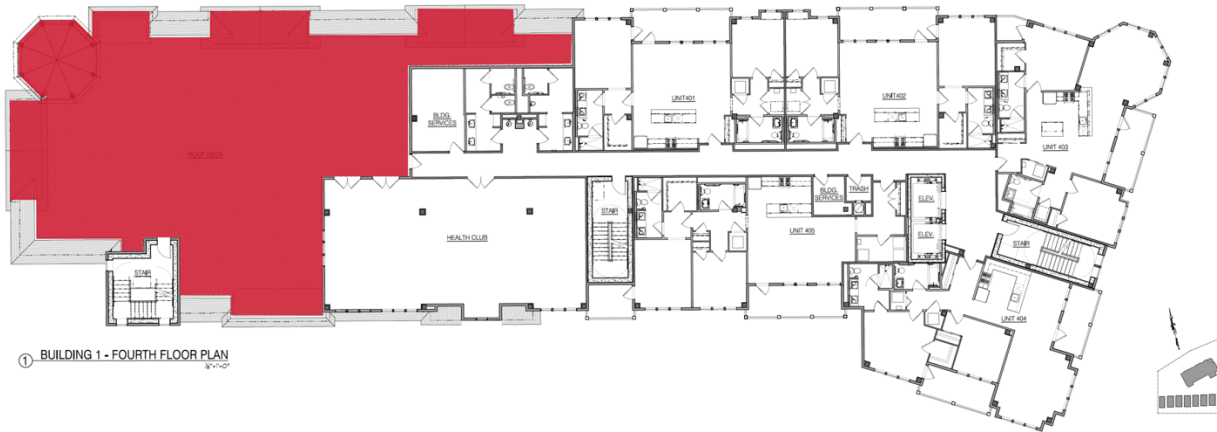
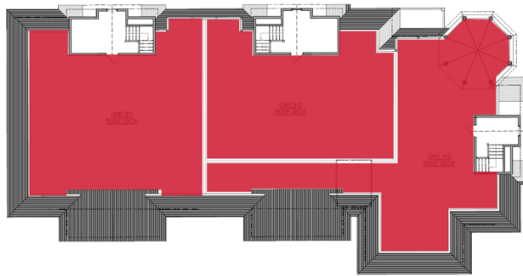
Illustration N.1.a. — Proposed coverage of Hotel Roof deck (emphasis added) (Sheet A-10).

Illustration N.1.b. — Proposed coverage of Condominium Building One east roof deck (color added) (Sheet A-4).

Illustration N.1.c. — Proposed coverage of Condominium Building One west roof deck (color added) (Sheet A-3).

Illustration N.1.d. — Proposed coverage of Condominium Building Two, three private roof decks (color added) (Sheet A-7).

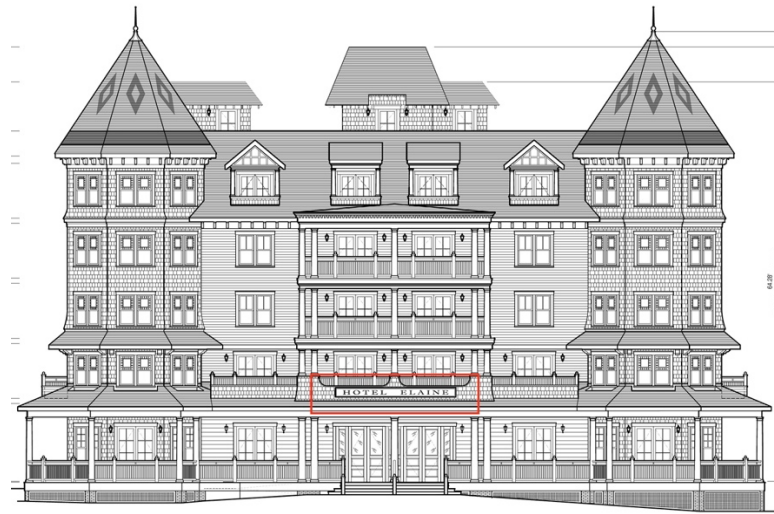
P.1. — No signage schedule was submitted for review by Tech. Excluding the name of the Hotel, which appears on the south elevation (see illustration, below) the current Plan is missing any indicators of type, style, or location of signage on, or around, any of the proposed structures. (See, Commercial Guidelines, Section Q, pages 20-23, “Signs are one of the most prominent visual elements on the street and define the purpose of a building. If designed, signs add interest and variety to the streetscape and building facade while enlivening the street scene. Poorly conceived signs may also detract from the architecture and negatively impact even the best designed storefront...).

Illustration P.1. — South elevation of the Hotel showing proposed signage (Sheet A-11).
