13 April 2022

Following OGNED's meetings before the Historic Preservation Commission (HPC) on 6 & 27 April 2021, three members—Deborah Osepchuk, Lucinda Heinlein, and Jeffery Rudell—were asked by Bernie Haney, to meet and offer feedback to the development team on ways their application (the Plan) could be brought into conformity with the Architectural Design Guidelines (Guidelines). These meetings were similar to the informal weekly Tech Review meetings available to all applicants to the HPC.

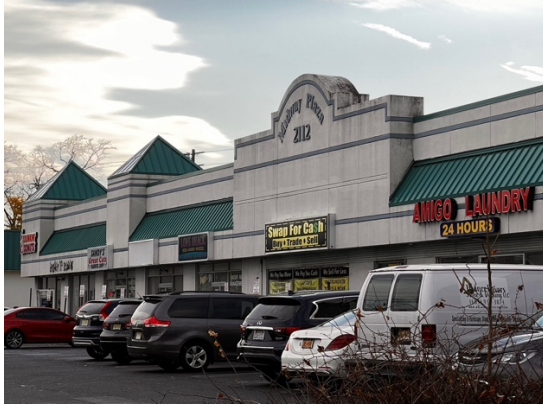
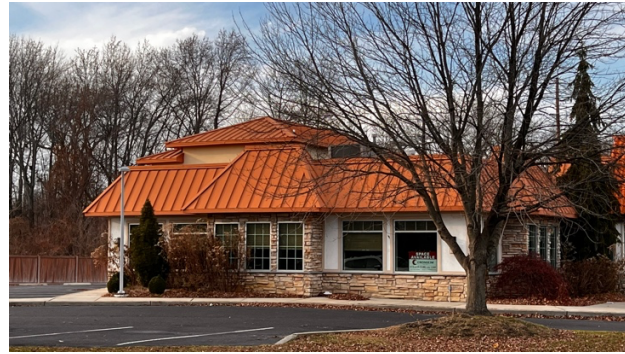
Illustration C.12.b., C.12.c. — Reference photographs showing modern, standing-seam roofs on area commercial buildings.

C.13. — **Condominium:** The main entrance to Building One (south elevation) has a non-conforming standing seam roof. (See Guidelines, page 14, 4: “Avoid use of modern standing seam factory painted metal roofing, and shingles of inappropriate historic period color, such as white or green.”)

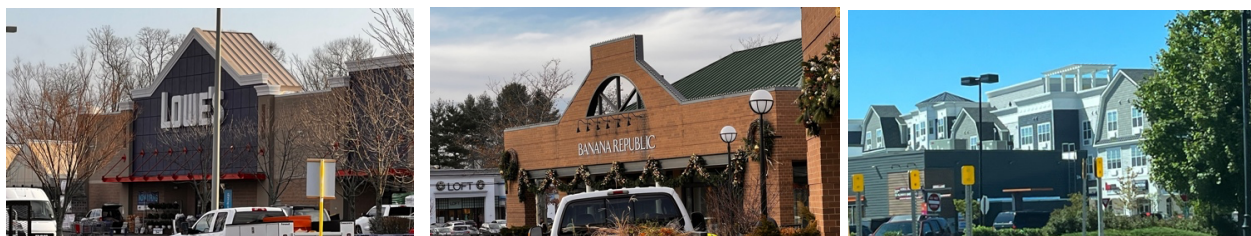
C.15. — **Condominiums:** Tech found the proposed faux-gables that dot the Condominium roofs especially counter-historical. Each faux-gable has an opening cut into its façade (some square, some arched) in a manner that Tech felt looked less architectural than theatrical. The artificiality of these forms is evident from vantage points to the west, north, and east. Faux-gables at the fourth story rise, but do not connect, to other roof forms behind them in a manner that is visually awkward and non-historic. The roofline of both Condominiums is a collection of odd-shaped intrusions that look distinctly modern. Tech shared the following images with OGNED to help illustrate their view that the proposed faux-gables are distinctly modern and historically inappropriate.

Illustrations C.15.e., C.15.f., and C.15.e. — Reference photographs showing faux-gable roof projections on area commercial buildings.

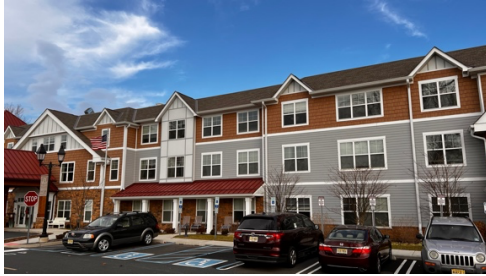
E.8. — **Condominiums:** Building One and Building Two include stacks of double and triple windows characteristic of modern fenestration patterns (see reference photo, below). Such modern window patterns are non-historic and lead to a “wall of windows” designs. Historic windows employ wider mullions and are only occasionally doubled. The south elevation of Building One employs double sets of stacked triple window above the main entrance (and elsewhere). Triple windows are historically inappropriate to the period of significance.

Illustration E.8.a. — Reference photograph showing modern double and triple window fenestration as found in a non-historic area residential structure. Note the use of a standing-seam roof in this contemporary example.

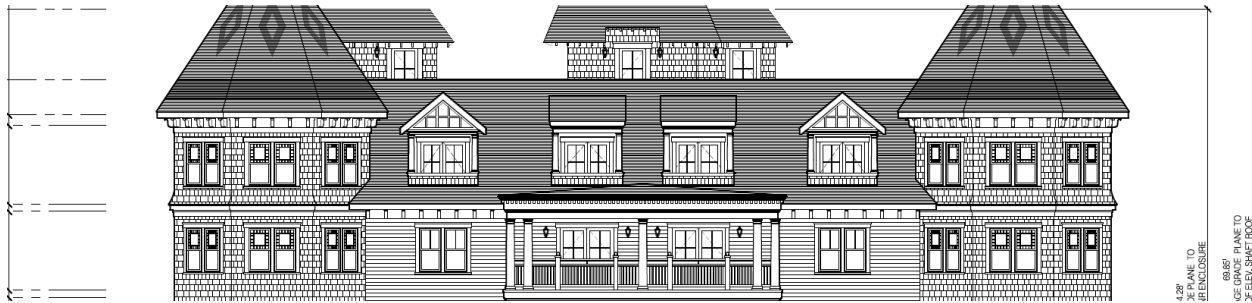
H.5. — **Hotel & Condominiums.** Turned and chamfered columns are more typical of Queen Anne designs than Tuscan columns. Turned columns were suggested to OGNED during Tech.

H.6. — **Hotel: Ramp.** It is unclear how the front entrance ramp railings will resolve with the wrap-around porch and its railings. Please clarify.

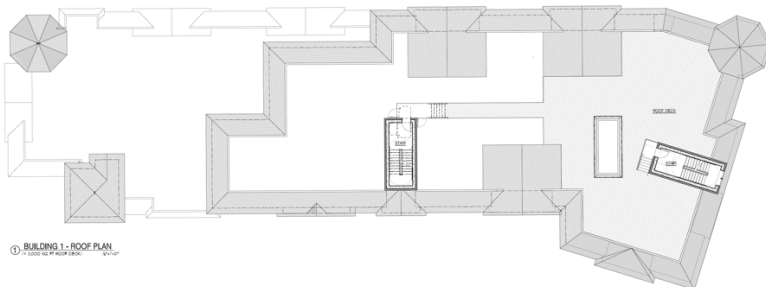
H.8. — **Condominiums:** Are railings proposed for the rooftop pathway and roof deck of Condominium Building One? Please provide cat/cut for review.

Illustration H.6. — Plan showing proposed Condominium Building One roof path and roof deck (Sheet A-4).

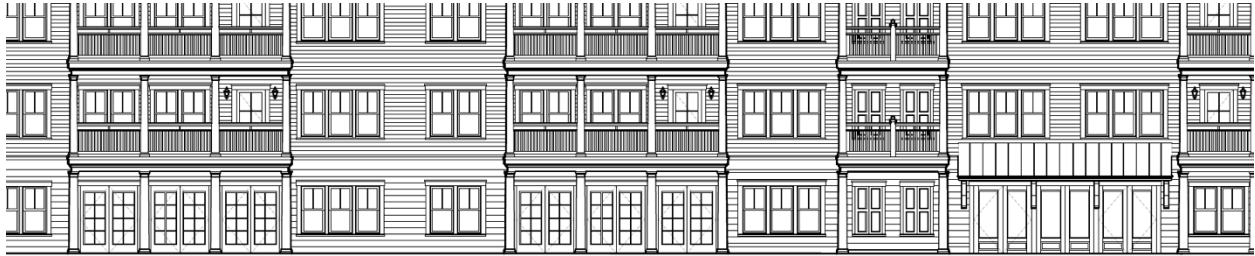
I.9. — **Condominiums:** No lighting is indicated at the entrance to Building One, not at the triple sets of French doors to the west of the main entrance. Is recessed lighting proposed in these areas? Recessed lighting is not historically appropriate and is generally not permitted within the Historic District.

I.10. — **Condominiums:** The lighting, while excessive, also appears inconsistent (e.g., no lighting is indicated on Condominium Building One, south elevation, in the stack of balconies directly above the Retail space).
